loway Creek

Brookside Park, Ames, IA

Existing Conditions Assessment & Restoration Concept

NREM 455L/555L, fall 2021
Iowa State University

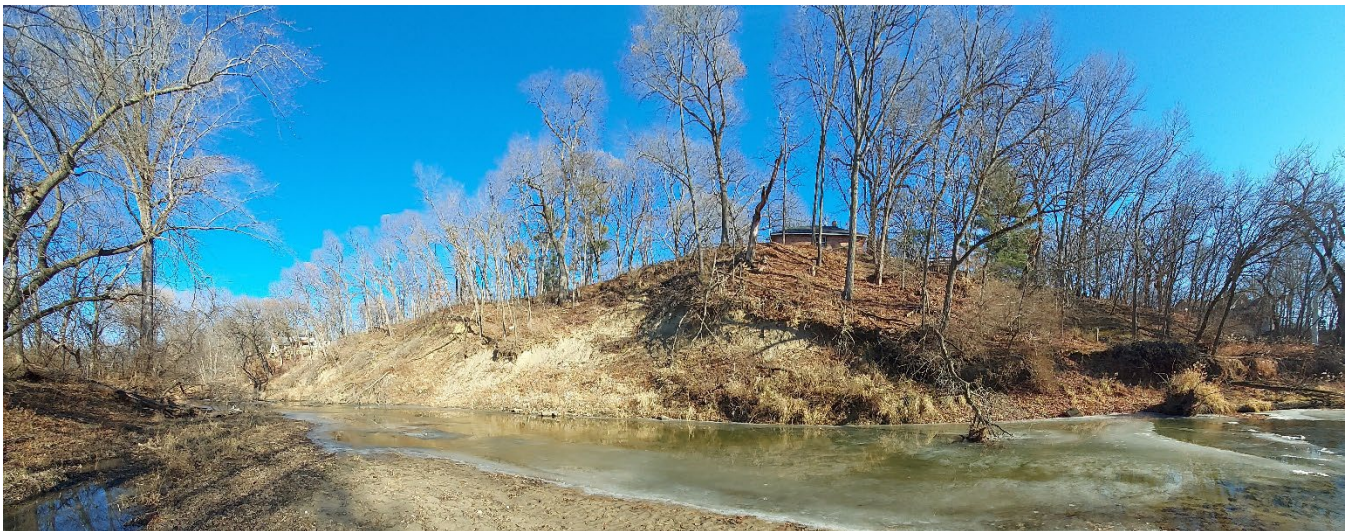
Figure 1: View of the till bluff east bank of loway Creek in Brookside Park from approximately station 11+00 (see Figure 2). Flow is from left to right.

This degrading bluff is the driver behind the need to restore the stream. Inaction here threatens private property, the utility of the stream as a stormwater conveyance system, biotic integrity, and the recreation potential of loway Creek. Nearby infrastructure constraints mean that the restoration of the channel should insist upon creating a stabilized channel that does not migrate. The nature of a stabilized channel compromises stream functions that can sustain healthy environments. Functioning, dynamic aquatic and riparian ecosystems are difficult to maintain when dynamic channel processes are stabilized.

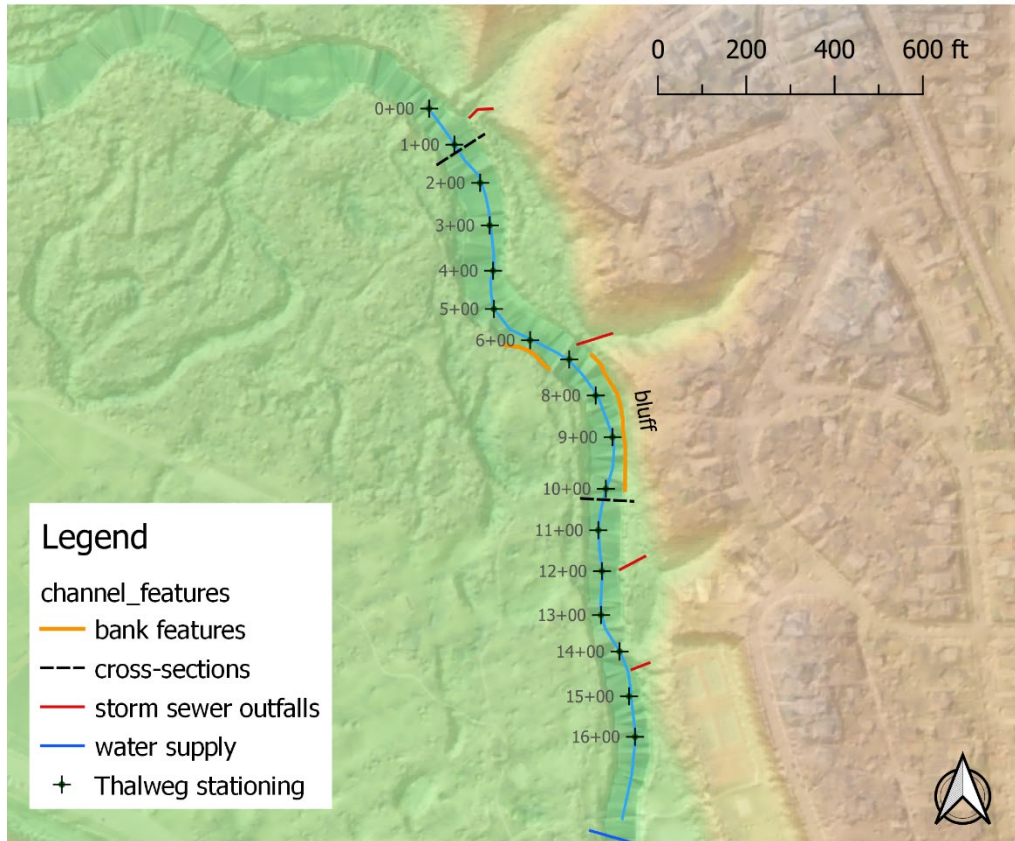
Figure 2. Survey station numbers (feet downstream from the northern footbridge in Brookside Park) and key features observed in the preliminary field survey.

Just downstream of the northern footbridge, a small storm sewer outfall on the east bank drains in to the creek. It has a damaged outlet apron and enters the creek through a short gully. The outfall and gully are poorly armored with broken chunks of old sidewalk. Downstream of that there is a section of undeveloped floodplain along both banks. About 500 feet downstream of the footbridge, there is large wood (also referred to as “large woody debris”) in the creek that spans most of the width of the channel. This large wood creates a diversity of flow regimes and potential habitat for aquatic species. There is also a large scour pool immediately downstream of the large wood, providing refuge for aquatic life during dry conditions. After that, the creek turns east. In the section that bears east – or about 650 feet downstream of the north footbridge, the west bank features another section of broken sidewalk doubling as bank armor. The east bank features a culverted storm drain that enters the creek. After that, loway creek largely straightens out compared to upstream sections. As previously mentioned, this is due to the stream running up against its valley wall and being confined there. The

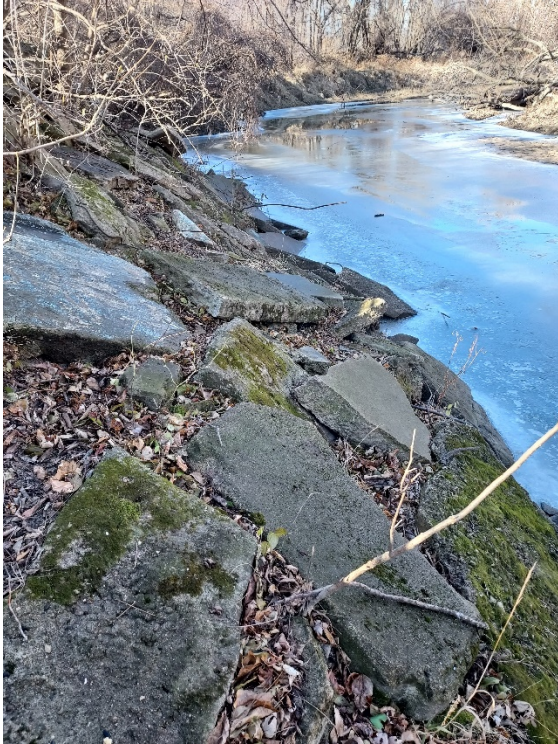
Figure 3. Photo of existing broken-concrete riprap along the right bank of Ioway Creek between stations 6+00 and 7+00.

- a. Remove problematic riprap between stations 6+00 and 7+00 on the right bank
- b. Regrade & vegetate banks where feasible, while preserving desirable trees
- c. Flow deflection and toe protection along bluff toe
- d. Channel definition structures on problematic bends (J-hooks, cutoff sills, barbs)
- e. Flatten bend across from bluff, shifting ~400 feet of channel 50-100 feet west at bend apex; build out bankfull bench at the foot of the bluff slope
- f. Re-route 800 feet channel through a floodplain channel scar; retain but stabilize the derelict channel at inlet/outlet as stormwater treatment pond/oxbow; re-grade floodplain remnant to a bankfull bench

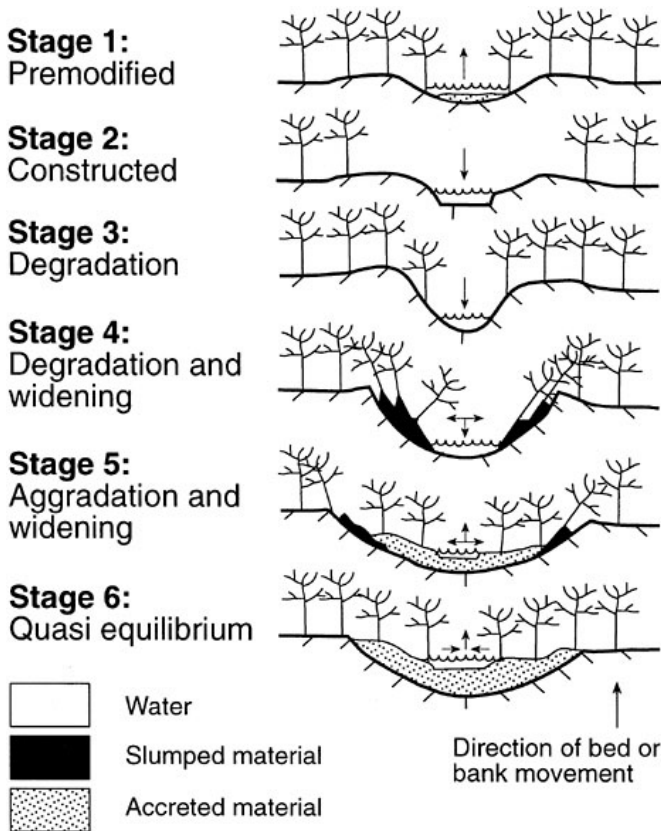
Based upon field measurements and observations described in this report, loway Creek is most likely in Stage 4 or 5 of Channel Evolution. Though the tall, steep banks and evident disconnection from the floodplain suggest past incision, it is likely no longer incising judging by the presence of large accumulations of bed material (mid-channel bars). This may be due to a combination of high sediment supply and existing grade control structures downstream. There is evidence that it is widening due to the signs of erosion and mass wasting events seen along the over steepened banks throughout the entire reach. Figure 5 below is a simplified conceptual model for natural stream evolution. In addition to the mass wasting and widening, Stage 4 and 5 show the entrance of large woody debris into the channel. A stream that is actively incising (Stage 3) will not show extensive mass wasting that widens the channel, or growth of mid-channel bars that represent aggradation.

Figure 5. The 6-stage channel evolution model of Hupp and Simon. loway Creek shows indications of both Stages 4 and 5 within Brookside Park.

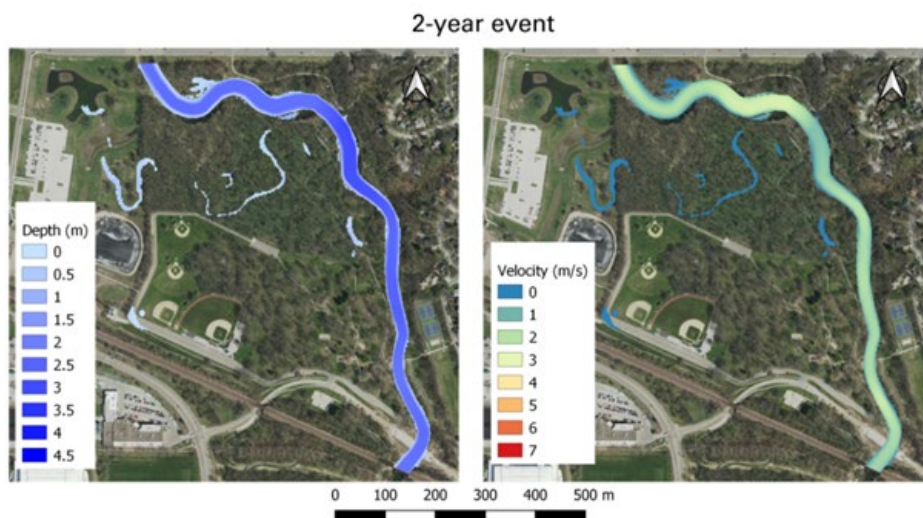
The depth results from the 2-year simulation indicates the channel is incised as the flows are still unable to access the floodplain. At the 2-year discharge in a healthy stream, water should be able to access the floodplain to provide flood storage, dissipate energy, and disperse sediments and nutrients. The velocity results indicate some areas of higher streamwise velocity corresponding with downstream changes in slope and width.

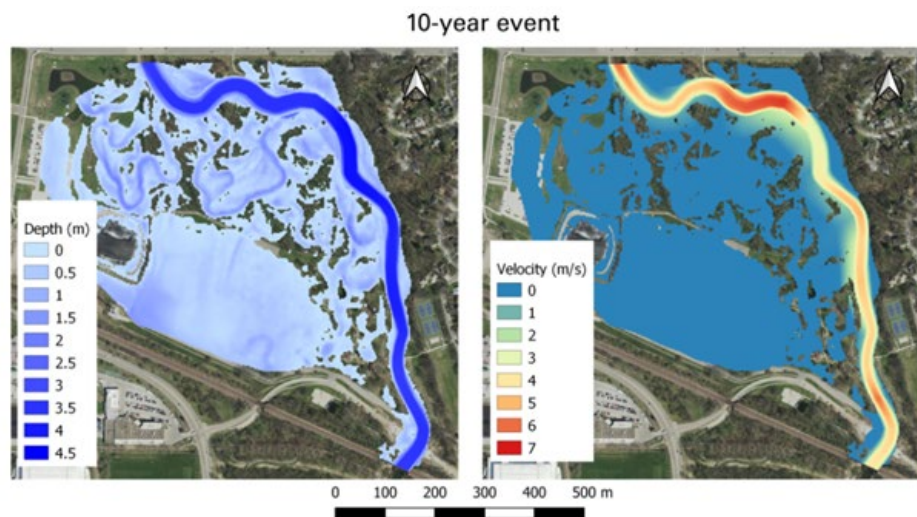
The 10-year event simulation results show the stream is able to access the floodplain at this stage. There remain a number of hotspots where the model predicts high velocities, particularly where the channel narrows. Several areas correspond to high priority erosional problems that the class identified in field. These are areas that may require additional stabilization to prevent future erosion problems. The model results suggest that since it takes a high stage for the stream to access the floodplain, bank

stabilization alone may not be enough. It appears that energy needs to be dissipated more efficiently across the floodplain.

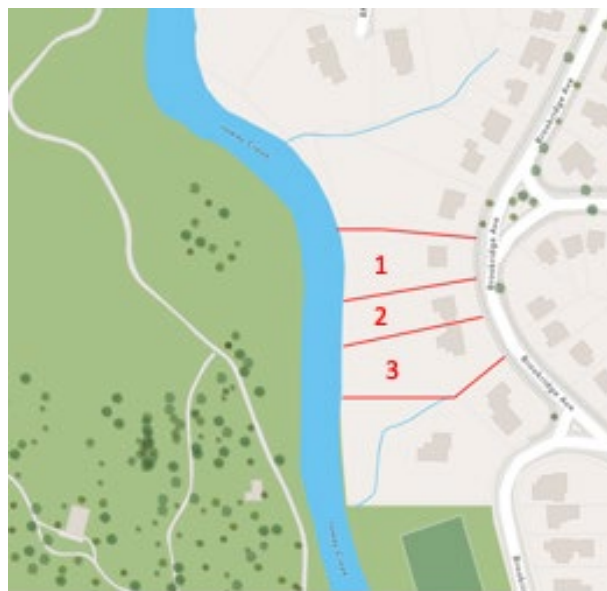
Several properties between Ioway Creek and Brookridge Avenue are currently at risk (Figure 19). The primary concern of these property owners is the slope erosion occurring on the till bluff. If nothing is done to mitigate further bluff recession, these landowners will continue losing property and, for one property owner, they risk losing a structure to the retreating slope within the next decade. However, for others, they risk losing garden space and landscaped yard area that they have worked hard to maintain. The affected property owners purchased this land with the expectation that the city could, at the very least, maintain their property lines and take action to ensure their land is not threatened by forces outside their control.

Figure 19. Map showing three residential properties that are significantly affected by erosion along the till bluff.

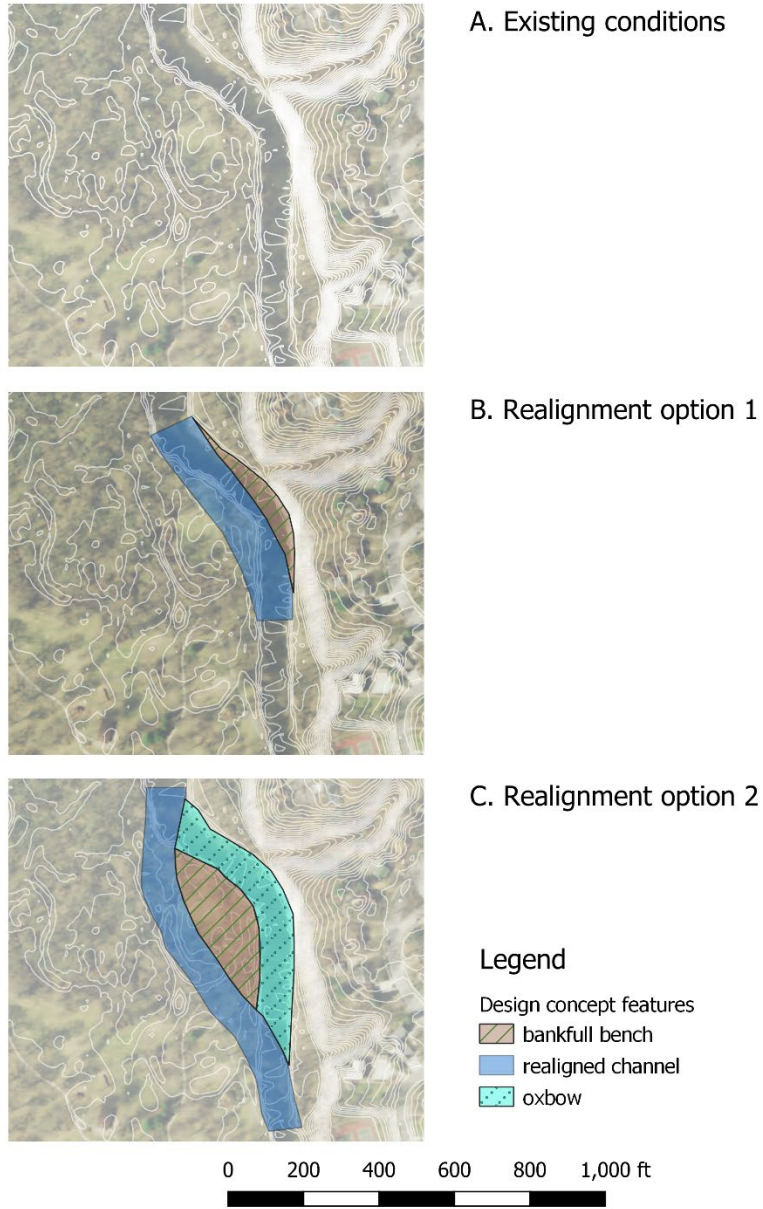
Figure 20. Existing conditions and two possible channel realignment scenarios for the channel segment along and upstream from the till bluff.
