# 2020 Annual Inspection Report Inactive CCR Surface Impoundment

City of Ames Steam Electric Plant

Report Number 272220309.00 | April 2021

Subject: 2020 Coal Combustion Residuals (CCR) Inactive Surface Impoundment Inspection

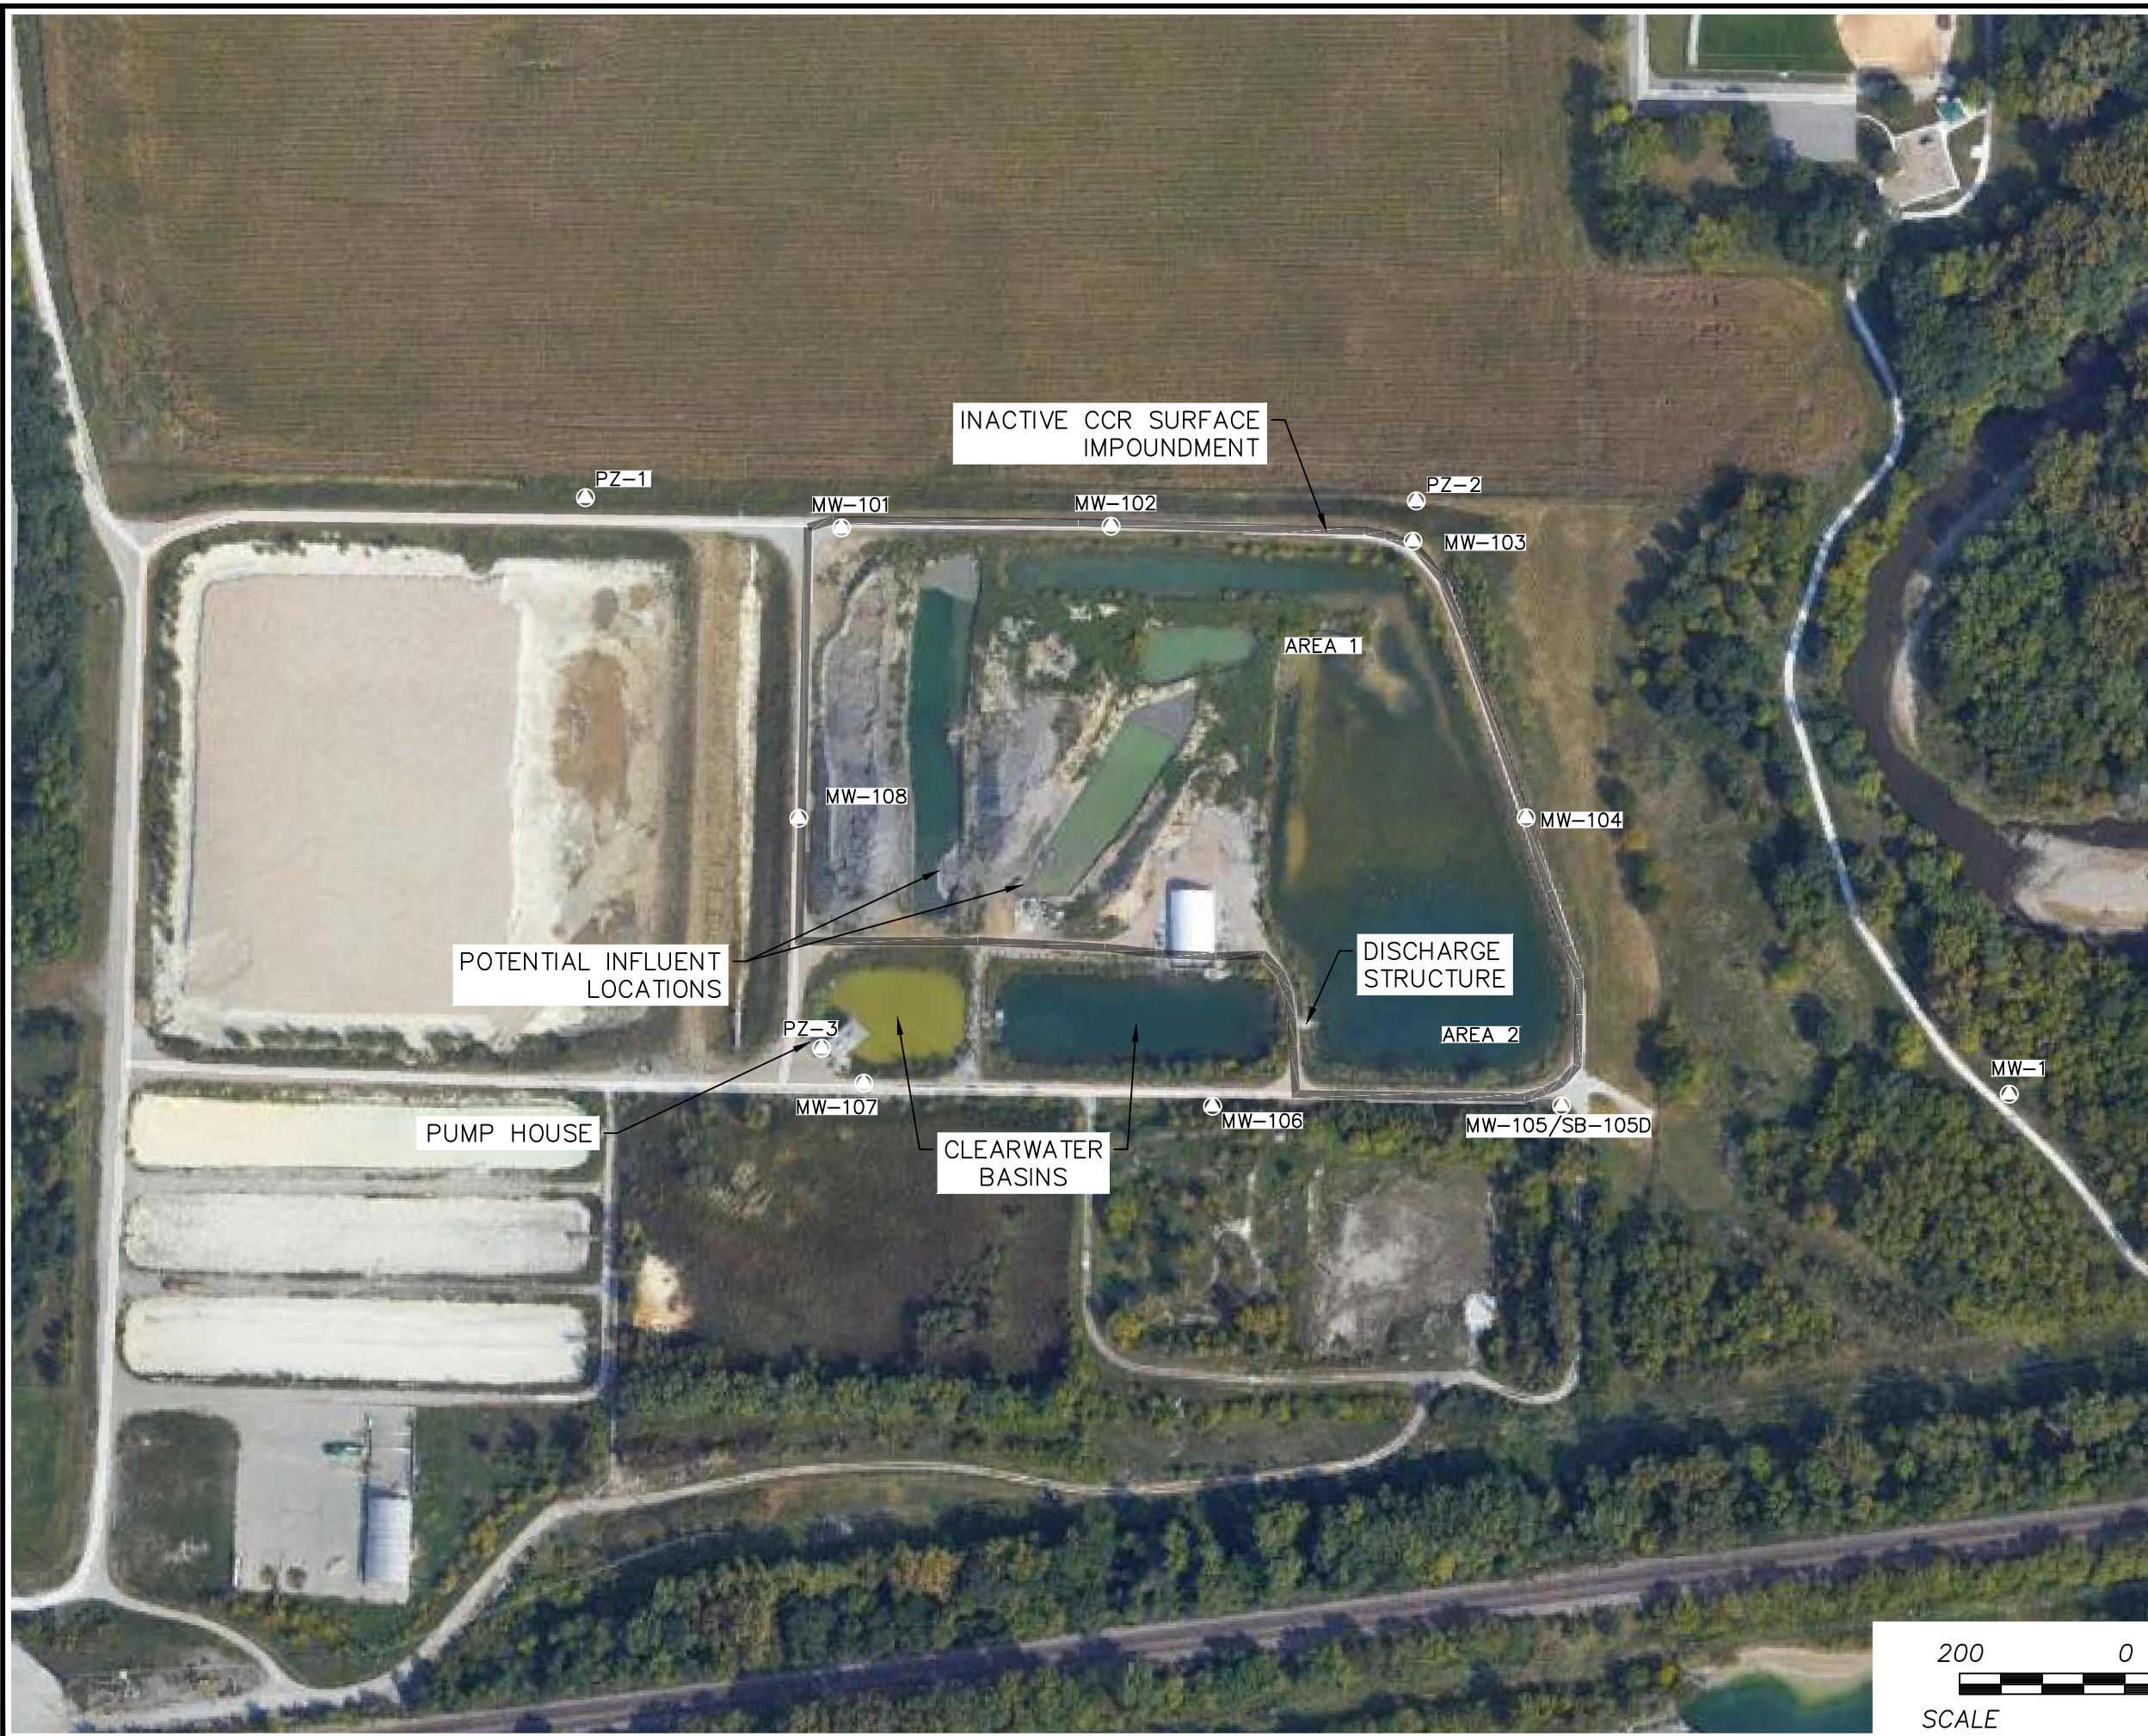
Item Noted	Comment	Action Level
Inappropriate vegetation growth	Trees were noted growing on both the upstream and downstream slopes.	Removal with routine maintenance
Animal impacts	Indications of beavers were noted based on tree marks. There was no observed animal activity in the exterior dikes. Area 1 on Figure 1 denotes area of past observations.	Continued observation
Erosion damage	Erosion noted in southeast corner of Impoundment on the inboard slope. Also noted in the last site observation. Ames Municipal Electric System are in the process of developing a plan for the future of the Impoundment. See Appendix A Checklist Notes, Area 2 on the aerial photograph for approximate area.	Repair with routine maintenance

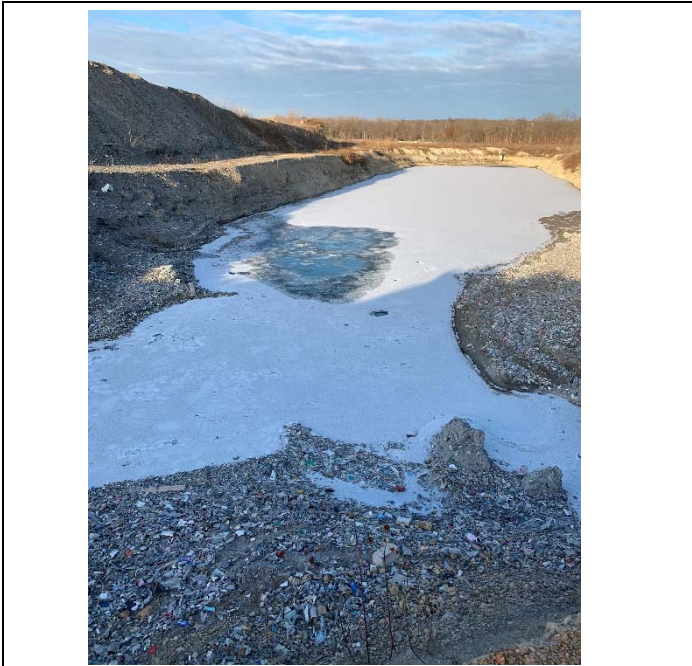
**Photo 1: 2019 East Ash sluice pipe to Ash Pond Receiving Ditch**

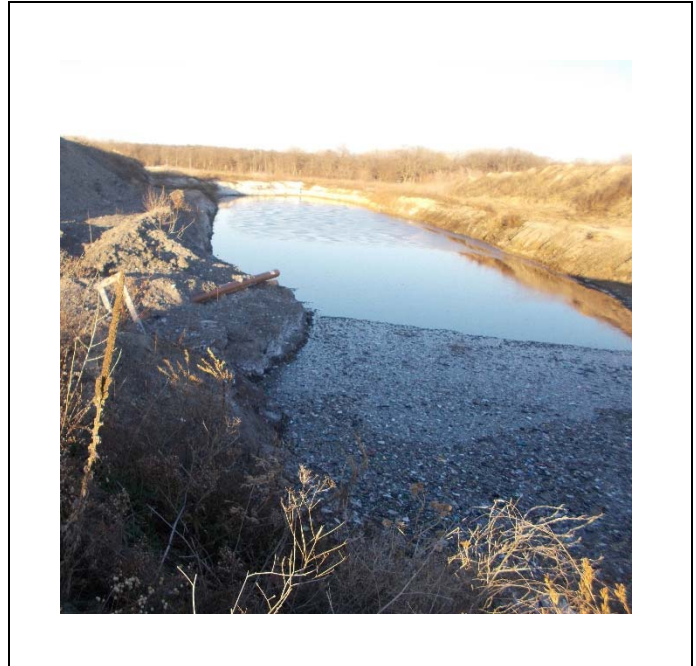
**Photo 2: 2020 East Ash sluice pipe to Ash Pond Receiving Ditch**

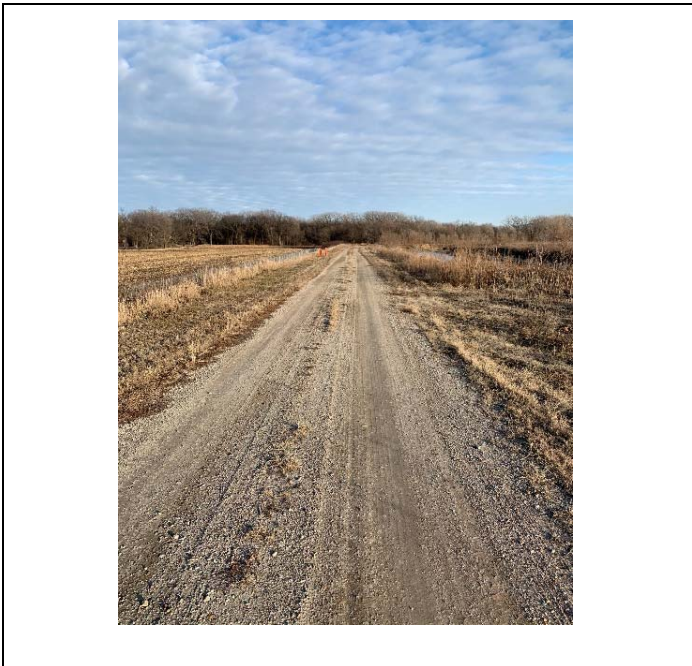
**Photo 3: 2019 North dike crest view east along Ash Pond**

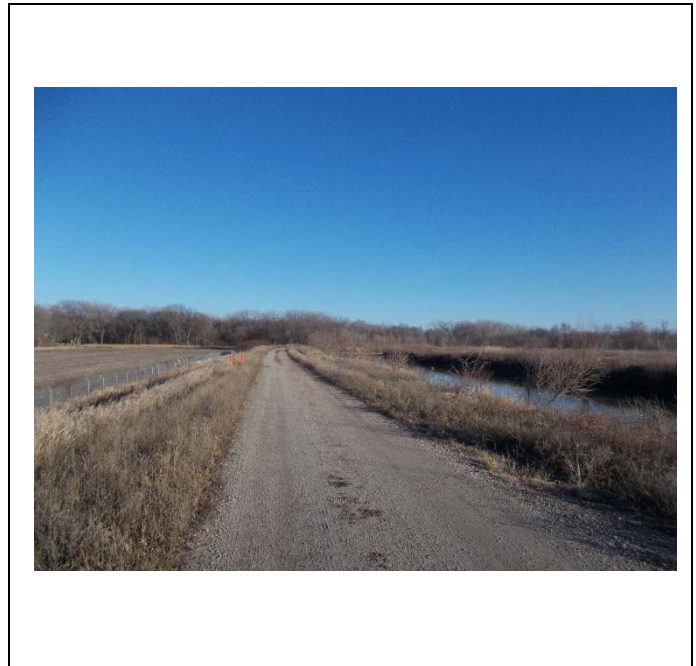
**Photo 4: 2020 North dike crest view east along Ash Pond**

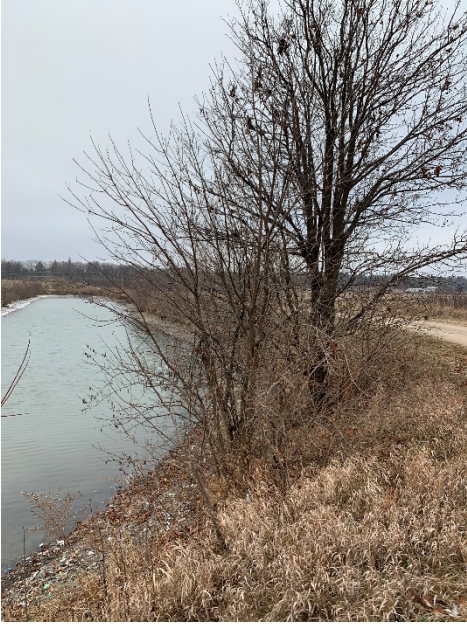
**Photo 5: 2019 North dike interior slope view west along ash pond**

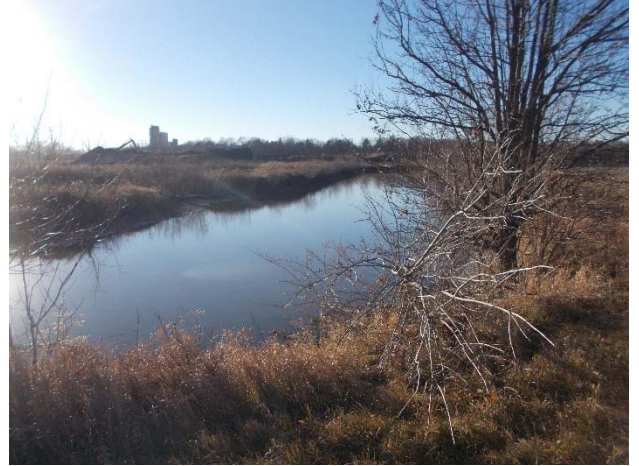
**Photo 6: 2020 North dike interior slope view west along ash pond**

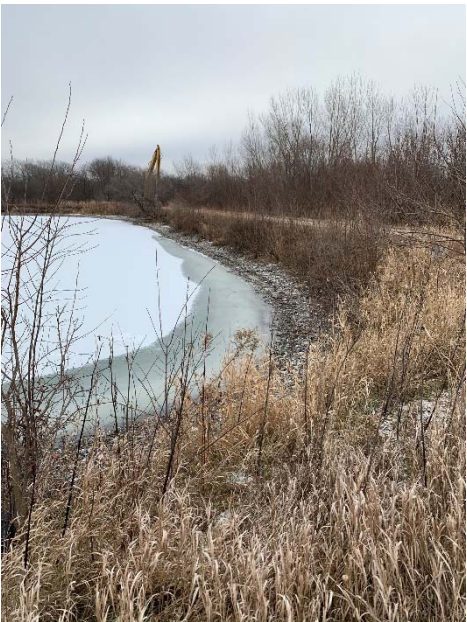
**Photo 7: 2019 Erosion along inside slope south embankment**

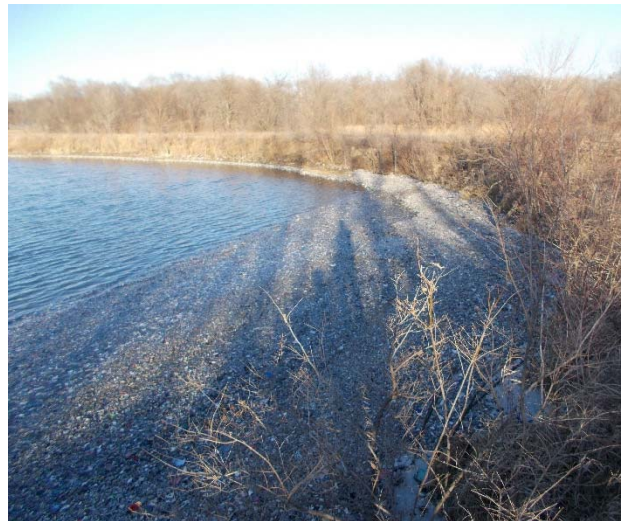
**Photo 8: 2020 Erosion along inside slope south embankment**

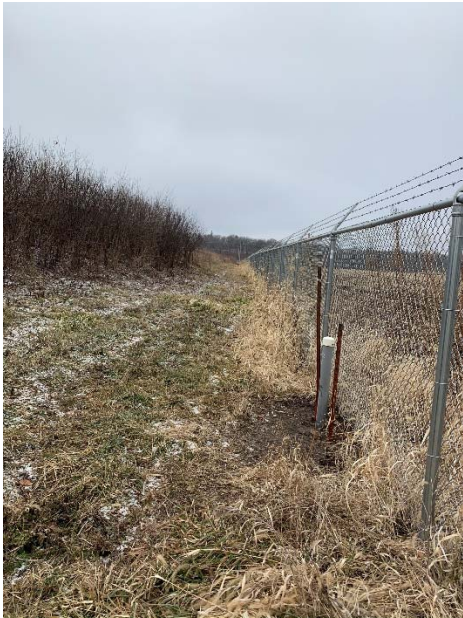
**Photo 9: 2019 Outside slope north embankment viewing west.**

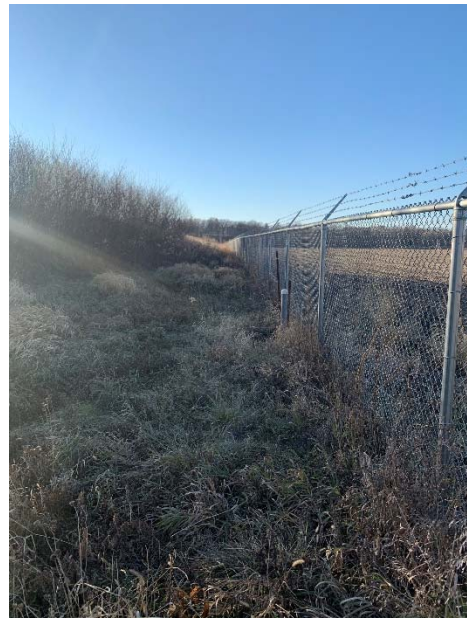
**Photo 10: 2020 Outside slope north embankment viewing west.**

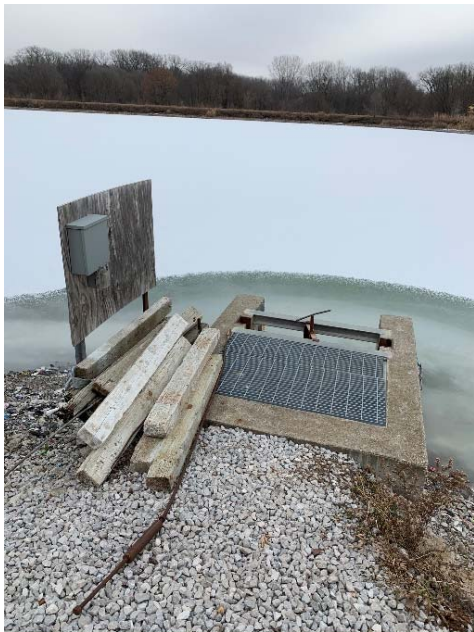
**Photo 11: 2019 Ash pond outlet structure**

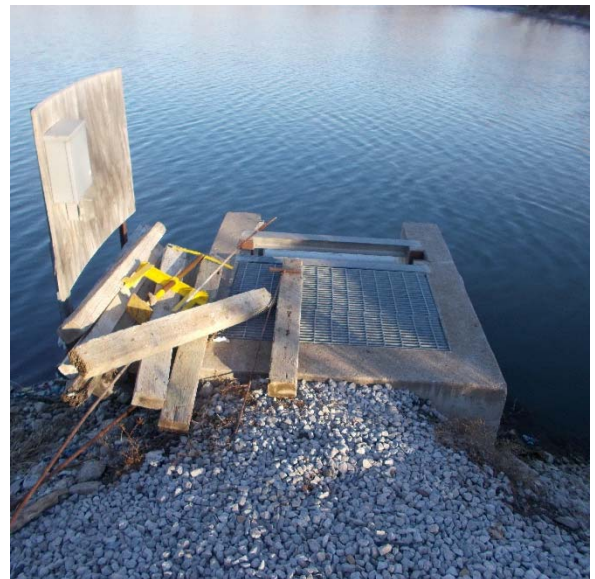
**Photo 12: 2020 Ash pond outlet structure**

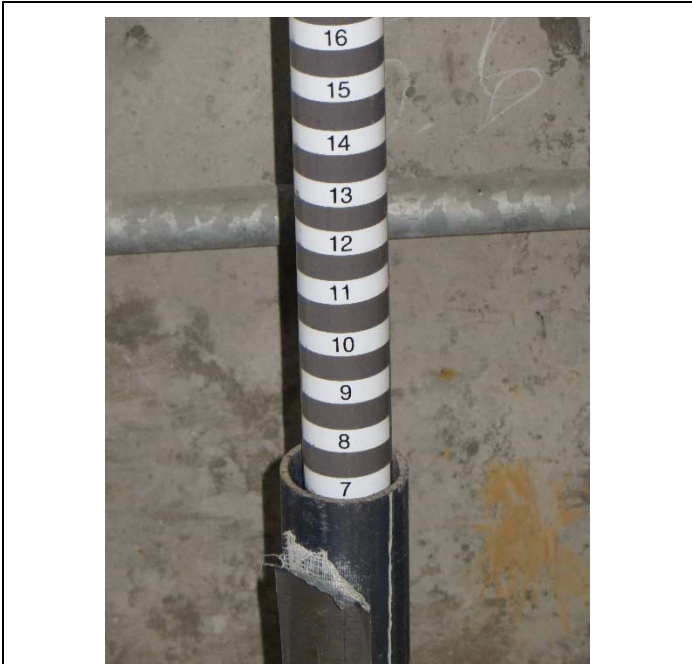
**Photo 17: 2019 Gauge located within pump house (CW-2)**

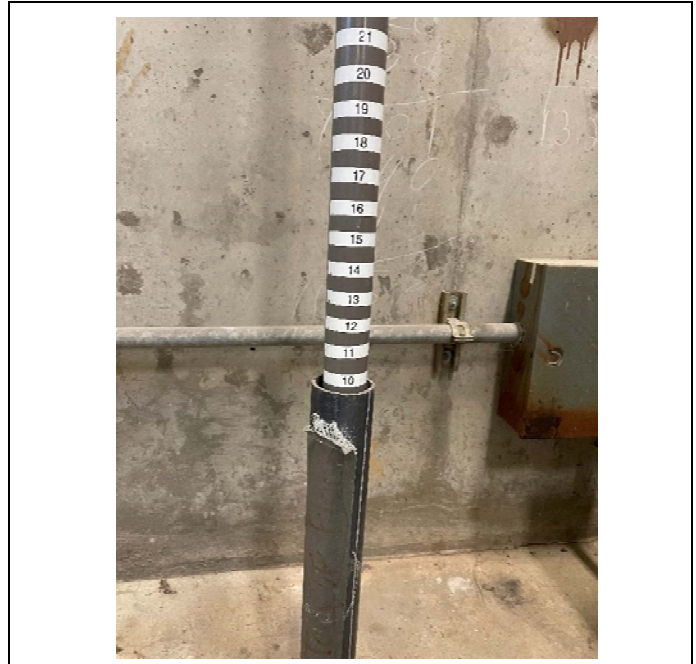
**Photo 18: 2020 Gauge located within pump house (CW-2)**

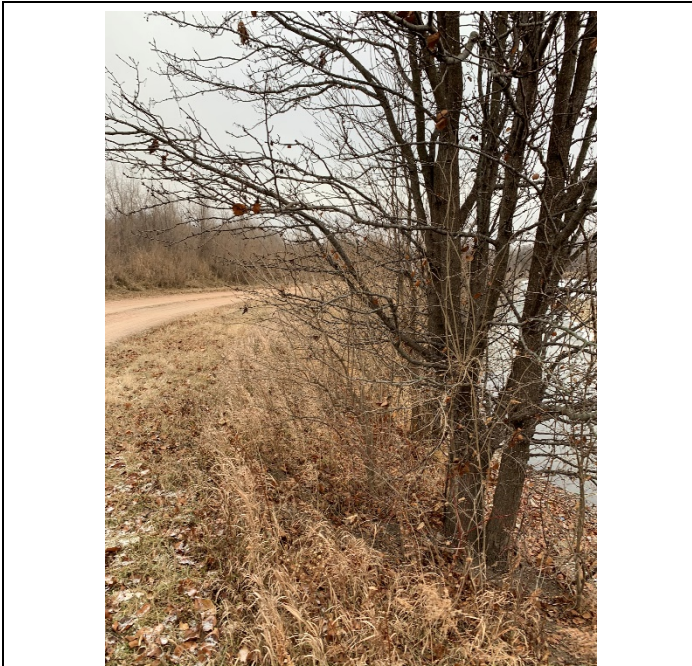
**Photo 19: 2019 Example of vegetative growth to be removed on northeast corner of the ash pond.**

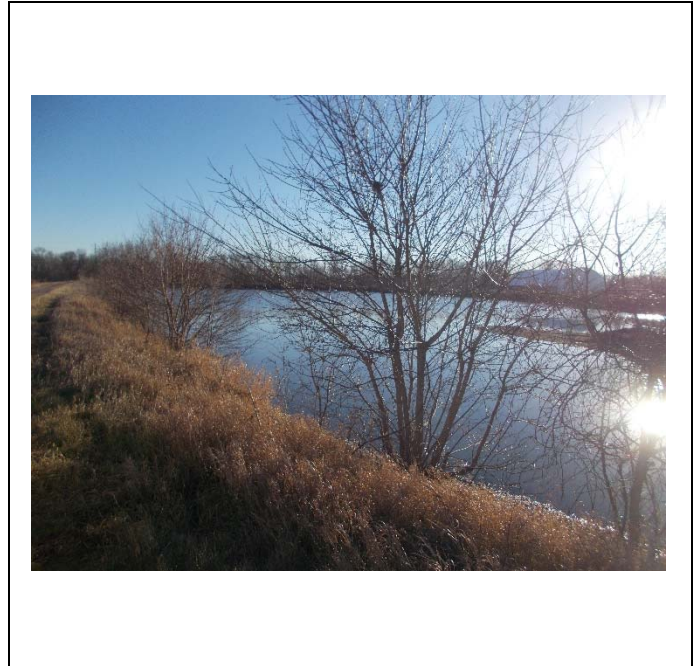
**Photo 20: 2020 Example of vegetative growth to be removed on northeast corner of the ash pond.**

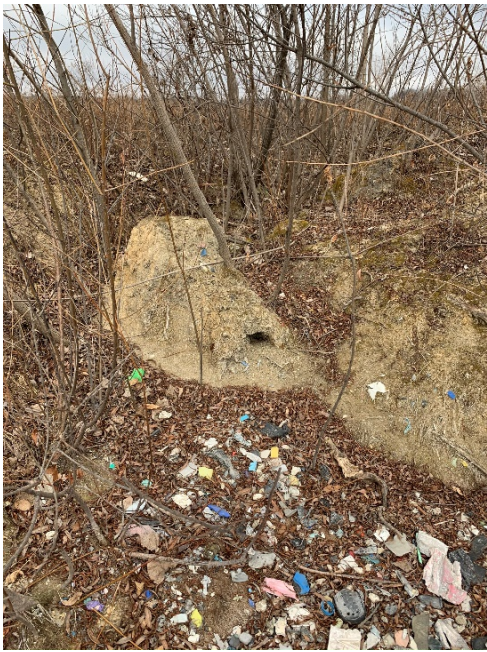
**Photo 21: 2019 Animal impacts. See Area 1 on aerial photo.**

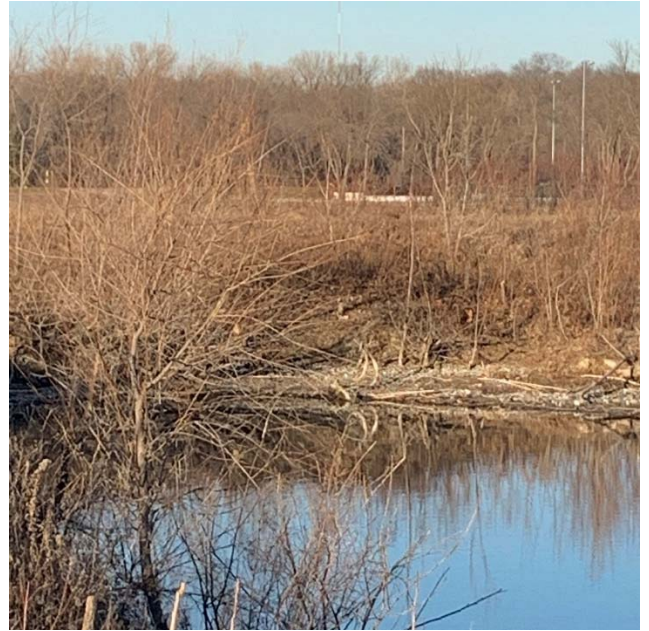
**Photo 22: 2020 Area of previously noted animal impacts. See Area 1 on aerial photo.**

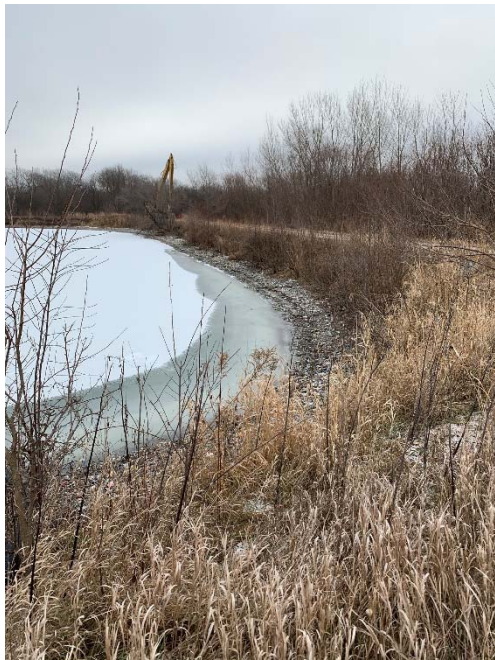
**Photo 23: 2019 Erosion on inboard slope southeast portion of the ash pond from south looking northeast. See Area 2 for location.**

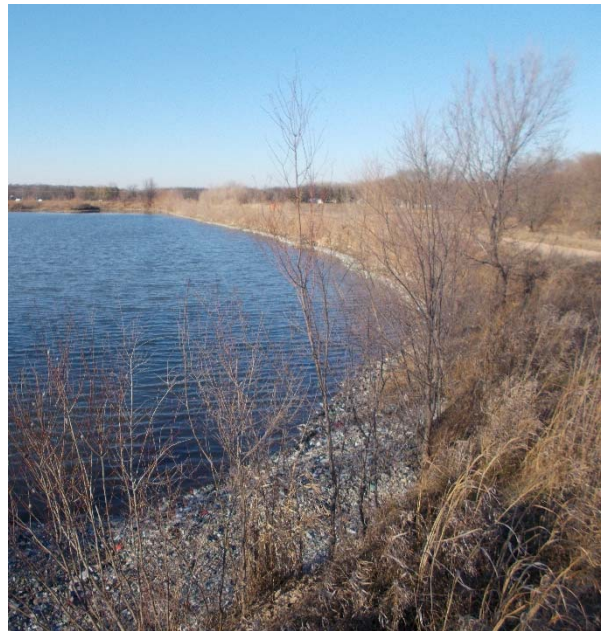
**Photo 24: 2020 Erosion on inboard slope southeast portion of the ash pond from west looking along the south/southeast. See Area 2 for location.**

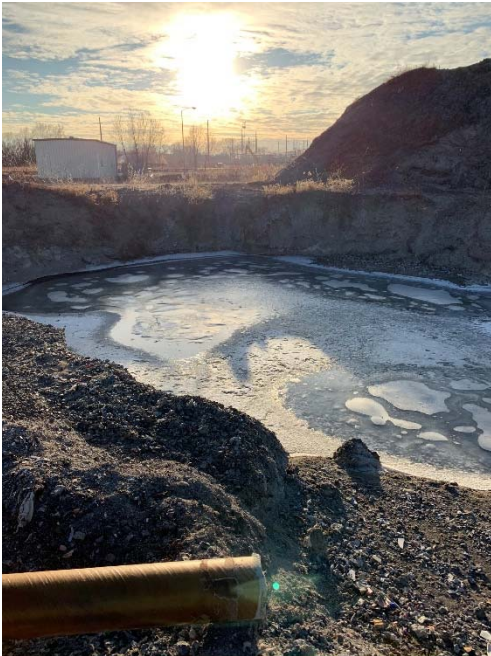
**Photo 25: 2019 Ash sluice pipe to West Ash Pond Receiving Ditch**

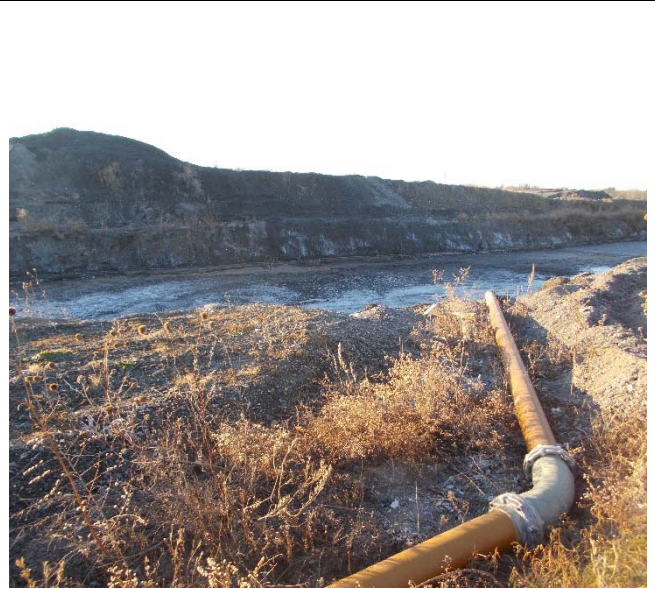
**Photo 26: 2020 Ash sluice pipe to West Ash Pond Receiving Ditch**

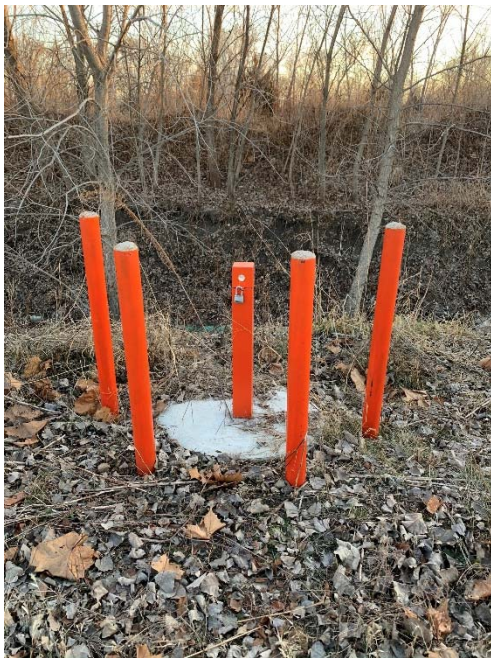
**Photo 27: 2019 Typical groundwater monitoring well installed in June 2018.**

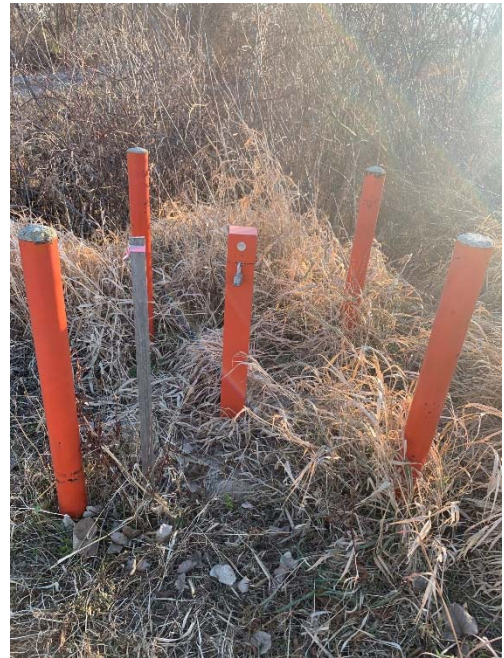
**Photo 28: 2020 Typical groundwater monitoring well installed in June 2018.**

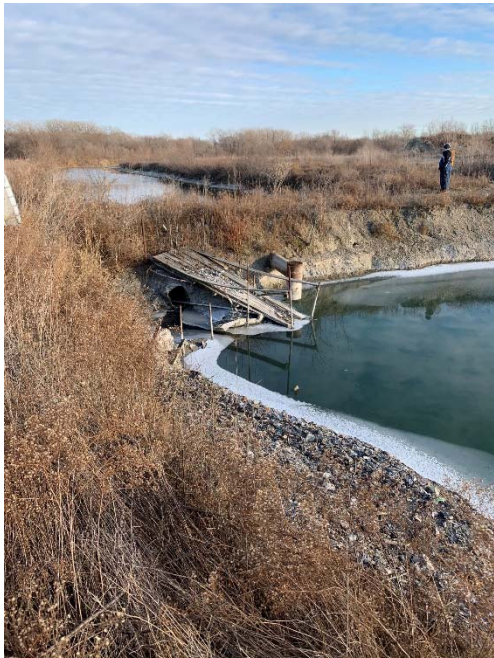
**Photo 29: 2019 Pipe structure connecting west channel to northern area in the ash pond.**

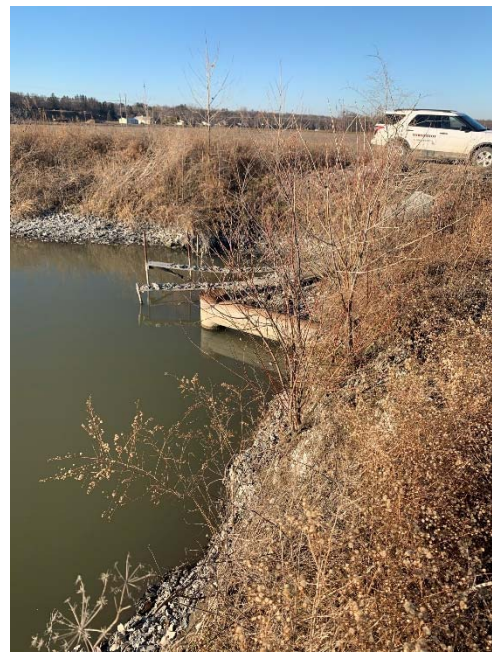
**Photo 30: 2020 Pipe structure connecting west channel to northern area in the ash pond.**

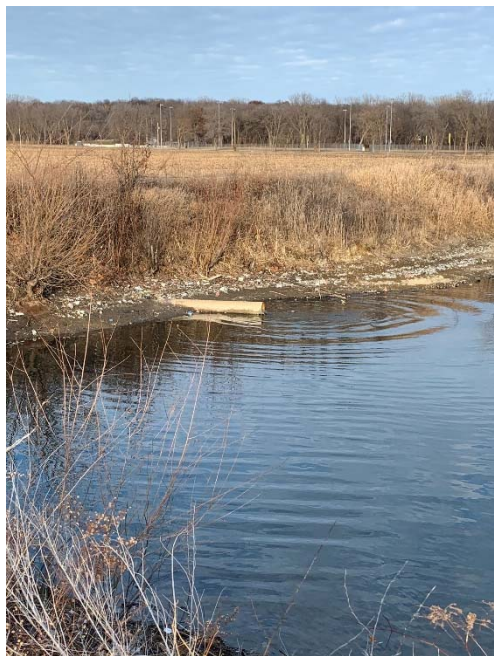
**Photo 31: 2019 SEP floor drain and cooling tower blowdown discharge pipe into the north side of north storage area in the ash pond.**

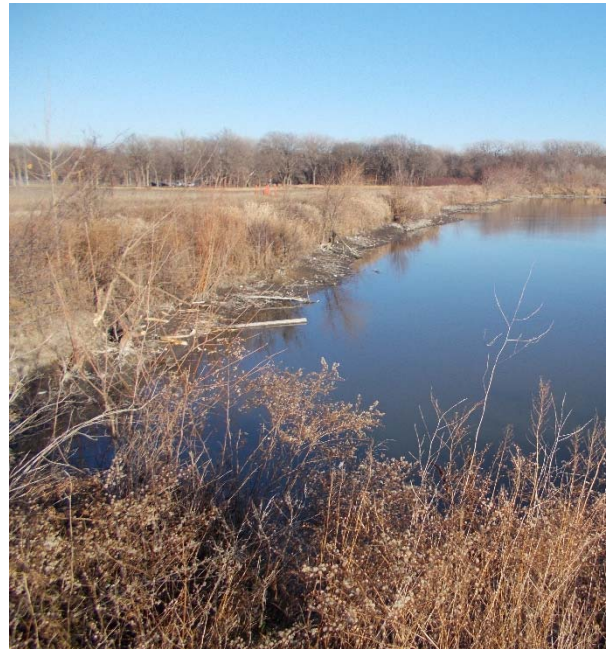
**Photo 32: 2020 SEP floor drain and cooling tower blowdown discharge pipe into the north side of north storage area in the ash pond.**

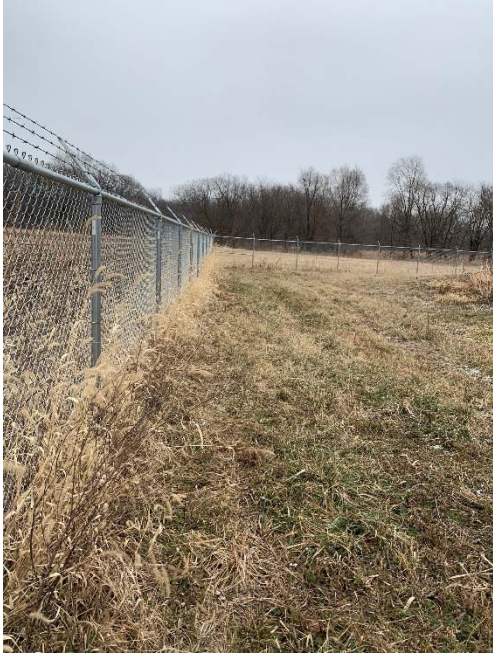
**Photo 33: 2019 Chain link fence installed around perimeter of the ash pond property.**

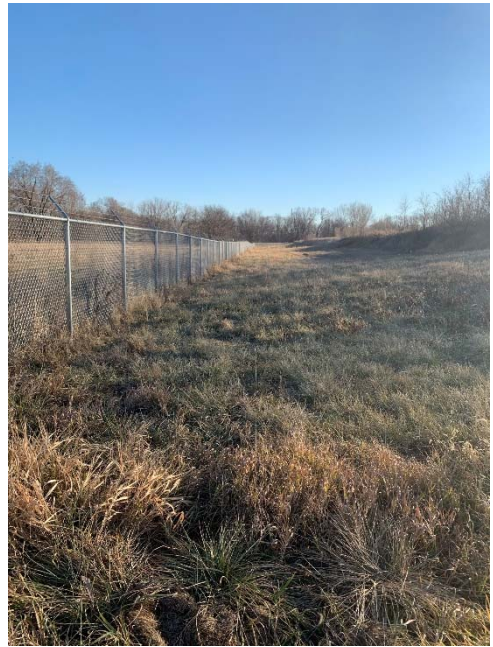
**Photo 34: 2020 Chain link fence installed around perimeter of the ash pond property.**
