## Staff Report

**PROPERTY SALE HARDSHIP EXCEPTION**

**Request for Consideration of Financial  
Hardship Letter of Compliance**

**107 S. Riverside Drive  
Ames, IA 50010**

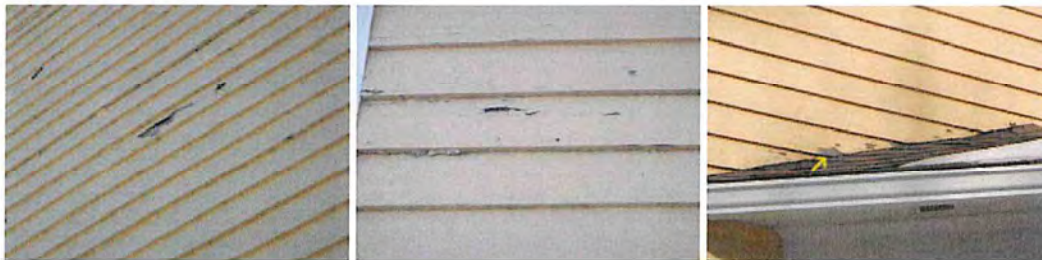
## EXTERIOR WALLS

Wood Siding: Failing paint or stain coatings observed on the siding. If not corrected, deterioration of the bare wood could occur. Proper refinishing and caulking is recommended.

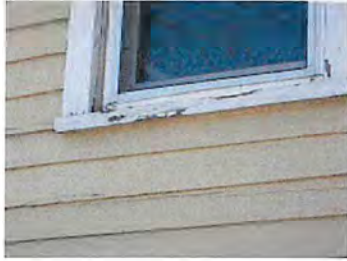
**EXTERIOR TRIM**

Missing or failed coatings or paint noted on the exterior trim. Proper refinishing and caulking is recommended.

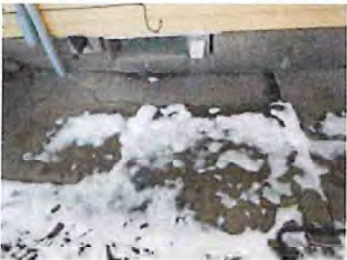
**PATIO(S) & WALKWAY(S)**

Settlement and cracking was noted at the building's walk(s). This is usually caused by shrinkage of the concrete as well as compaction of the soil under the walkway(s) over time, and usually occurs only in the first few years after the walkway(s) are installed. Some areas can be a trip hazard.

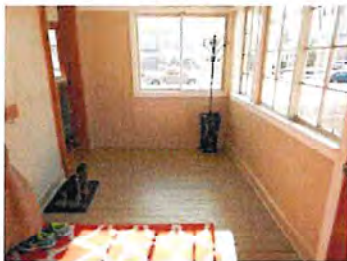
**DECK(S), PORCH(S), BALCONY(S) & RAILING(S)**

The side porch slopes downward. This is considered normal for older homes. Monitor for change and make any necessary repairs to structure as needed.

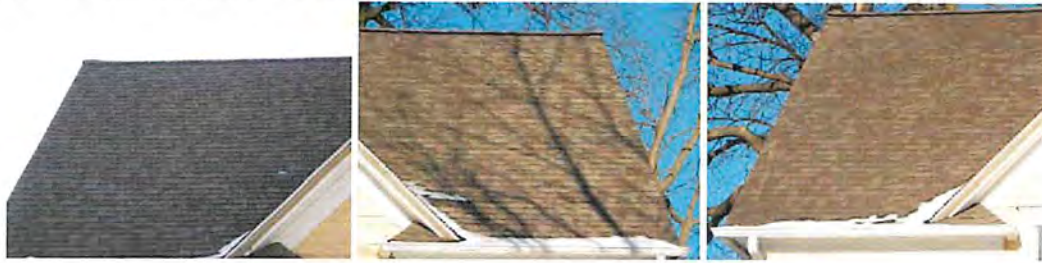
### **SURFACE MATERIAL(S)**

Normal wear observed for the estimated age of the roof.

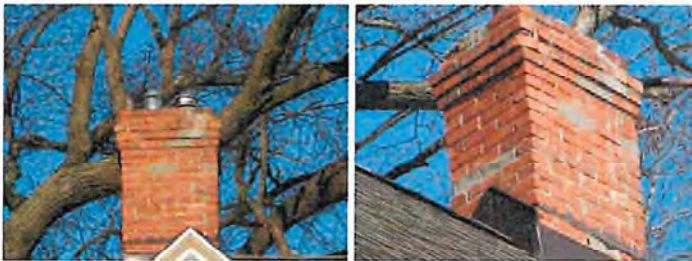
### **CHIMNEY(S) & CAP(S)**

Brick Chimney(s): This inspection is limited to the visible sections of the chimney. The interiors of chimney flues are not fully visible and therefore cannot be thoroughly inspected. I inspected the visible sections of the chimney, and only those visible portions are represented in this report. A chimney specialist can provide a more comprehensive inspection of the flues and any other inaccessible portions. It is always advisable that the chimney be professionally cleaned and inspected before use. Chimney specialists, as well as some other contractors, are typically called when someone has a problem that needs correction. This being anticipated, contractors generally assume that you are anticipating that work will be needed. Please be sure to explain to the chimney specialist that you are requesting an inspection and evaluation of the chimney and its ability to function properly, and are not requesting a proposal for work. This will probably require an inspection fee to compensate for the contractor's time. More information about the care and operation of your chimney and/or fireplace can be obtained by contacting "The Chimney Safety Institute of America" at their web site: [www.csia.org](http://www.csia.org). Repairs have been made to the chimney and should be monitored for deterioration.

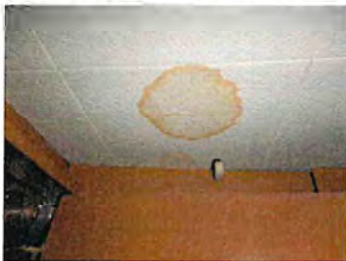
Staining (apparently from moisture) was observed in one or more areas of the ceiling(s): The staining was DRY. Recommend monitoring of the staining and/or checking with the current owner. It is also recommended to determine and correct the source of the staining if still active. Located in the basement.

Cracks were observed that are common to drywall and plaster ceilings. These are usually cosmetic and may be repaired as desired however, monitoring of all cracking for possible movement is recommended. Some cracks will re-occur as a result of normal expansion and contraction from changing indoor humidity levels and seasonal changes.

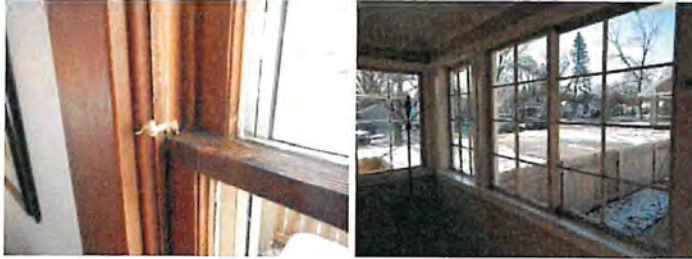
The glazing compound (putty) is failing around the glass at one or more windows. This is usually due to normal aging, and is often worse on the south and west sides of the house (because of the sun). Glazing compound holds the glass in the window sash. Recommend removal and replacement of any loose putty with fresh putty. These include: Living Room.

One or more windows were stuck closed. They are likely painted shut, but may also have hardware malfunction. Recommend all windows operate smoothly for proper ventilation and for personal safety. These include: Porch.

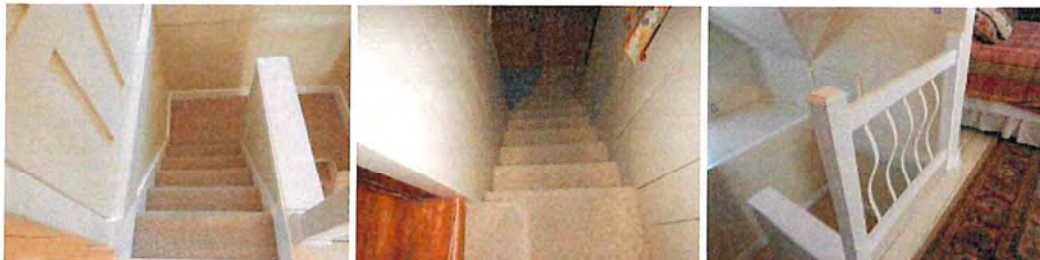
No handrails were present, and the surface rise or height differential is enough to present a possible safety hazard. Installation of proper railings is recommended.

Loose handrail(s) were observed at one or more locations. This is potentially hazardous and proper repair of all loose handrails is recommended for safety.

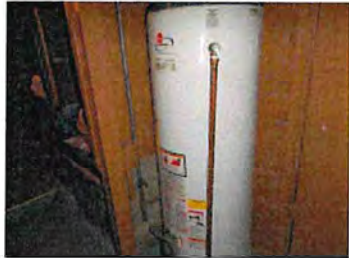
| | | Reviewed | N/A | *Comments |
|--|--|---|---|---|
| Water Heater #1 | Size: 50 gal. Type: Gas, Est. Age: 7 Years. | <input type="checkbox"/> | <input type="checkbox"/> | <input checked="" type="checkbox"/> |

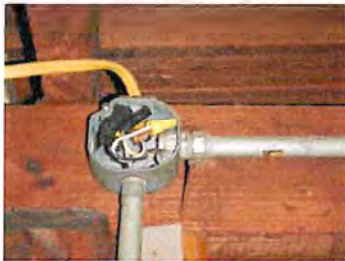
Open junction boxes were observed. Recommend all junction boxes have proper covers installed for personal safety. Open Junction Box Location(s): Basement.

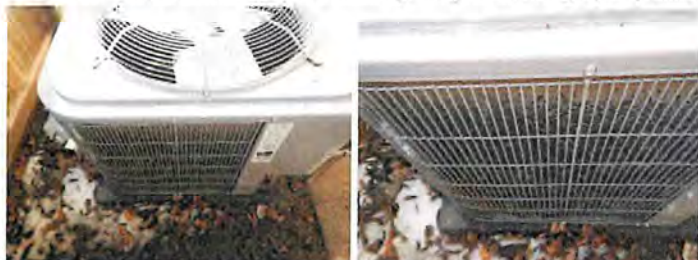
**Forced Air:** We were unable to test the air conditioning unit(s) due to the outdoor temperature being less than 60 degrees F. The exterior compressor unit(s) can be damaged if it is operated at colder outdoor temperatures and it should be at least 60 degrees F for the previous 24 hours before the unit can be operated safely.

**Forced Air:** The exterior compressor/condenser unit would benefit from professional maintenance. The unit should be kept clean for maximum performance and efficiency. Proper servicing by a qualified heating contractor is recommended.
