# Iowa Site Inventory

1. Site Name MAX DUTCH BUILDING  
2. Village/Town/City AMES Township WASHINGTON County STORY  
3. Street Address 327 MAIN STREET  
4. Legal Location \_\_\_\_\_  
Urban: \_\_\_\_\_ subdivision \_\_\_\_\_ block \_\_\_\_\_ parcel \_\_\_\_\_ subparcel \_\_\_\_\_  
Rural: \_\_\_\_\_ township \_\_\_\_\_ range \_\_\_\_\_ section \_\_\_\_\_ 1/4 section of 1/4 section \_\_\_\_\_  
5. UTM Location: zone \_\_\_\_\_ easting \_\_\_\_\_ northing \_\_\_\_\_; Acreage \_\_\_\_\_  
6. Owner(s) Name \_\_\_\_\_  
7. Owner(s) Address \_\_\_\_\_  
(Street address) (City) (State) (Zip)  
8. Use: Present COMMERCIAL Original COMMERCIAL

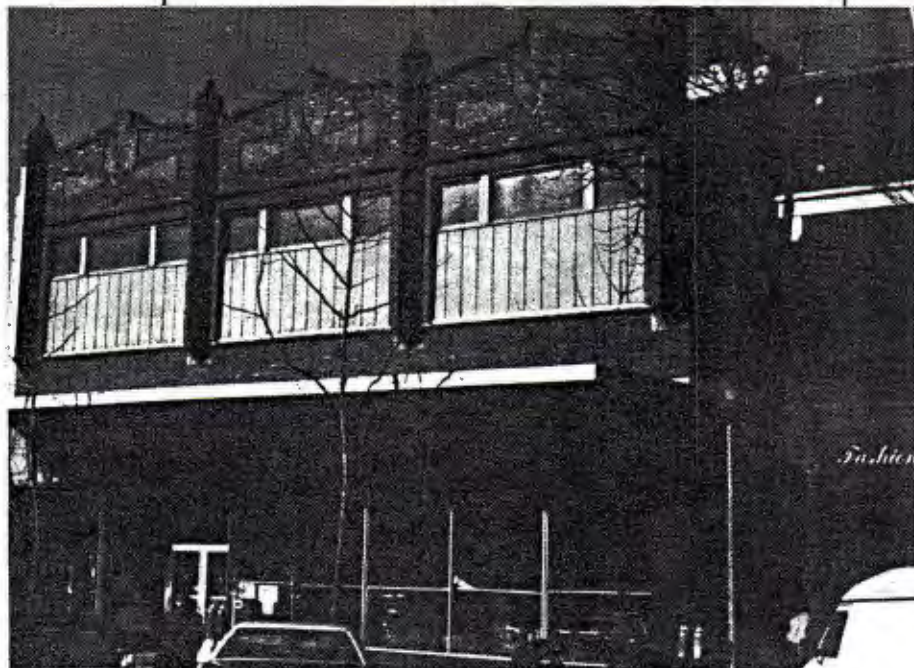
19. Photo looking N Photographer \_\_\_\_\_ Page \_\_\_\_\_

This building might contribute to an historic commercial district as a fine example of the commercial style enriched with Art Deco motifs. If the second story windows were unblocked and original material found to be intact, the appearance of this building would be greatly enhanced and its contributing status strengthened.

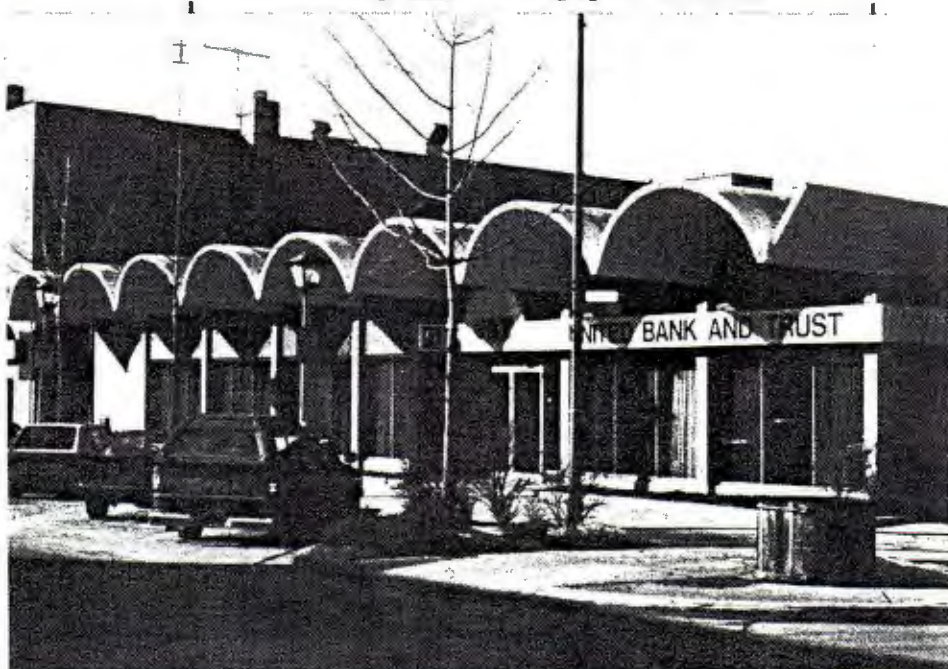
19. Photo looking NW Photographer Wirth

This is a one-story, brick commercial building. Located on the northwest corner of the intersection of Main Street and Burnett Avenue, this building is non-conforming to typical room organization of most buildings on Main Street. The building's arches on the facade worked somewhat in rhythm with those of the Collegian Theatre before that building was façademized.

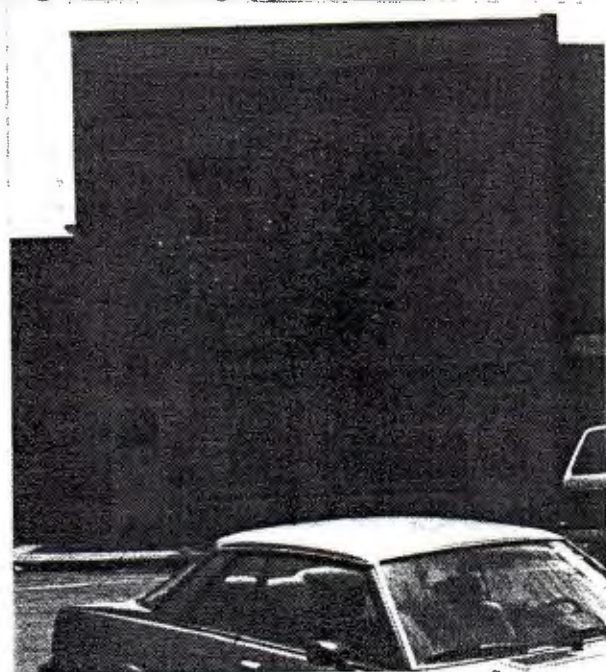
19. Photo looking S Photographer Wirth

The earlier facade is shown in an 1907 photograph of downtown Ames. This facade had, on the second story, four bays, and a simple brick cornice. When face lifted, the new design converted the second story into two bays, disposed of the cornice, and replaced it with the plaque, an architectural feature popular into the 1950s in Ames.

Although the doors and windows on the first floor appear to be replacements, this building retains high integrity from the 1950s, and the owners are encouraged to maintain the present facade intact.

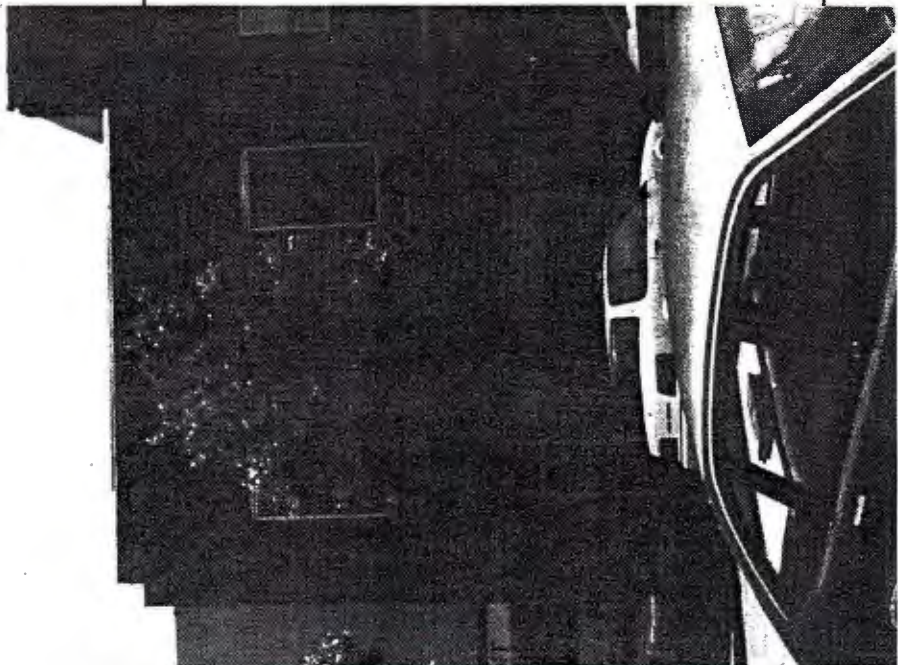
18. Map \_\_\_\_\_
19. Photo looking S Photographer Wirth

The original second floor windows have been replaced by single pane windows, and these alterations detract from the integrity of the facelifted design. Although the first floor storefront has been altered with a new door and windows, the original cavities remain intact, including the transom area. Original glass, perhaps of the Luxfer type, may remain behind the paneled-over transom area.

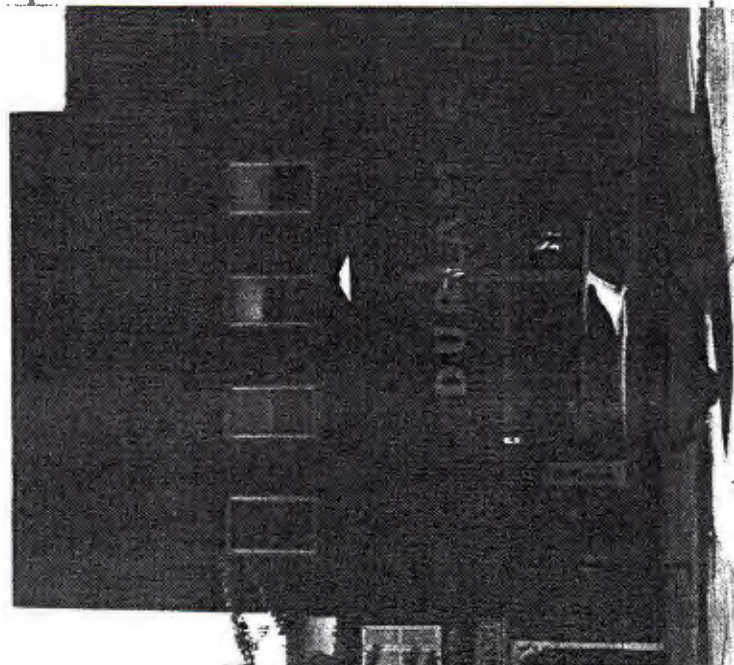
19. Photo looking S Photographer Wirth

The building features red, dark red and tawny yellow colored brick. There is a high parapet above the second floor windows. This area is decorated with a brickworked plaque consisting of brick laid in a basket weave design. Tile coping caps the building. Windows on the second floor feature 1/1 double hung sash type windows. They appear to be alterations from the original 1920s design which, perhaps, resembled those at 228. Sills consist of brick laid obliquely and butting out. Other brick details provide architectural interest to the facade. These details include a band of soldier laid brick separated by other courses of brick above the second floor windows. This band ties into a similar one at 228. The first floor storefront has been totally altered with rough, vertical wood siding in a gable end design to unite 228 and 226 Main Street. Although this design is very distracting to the historical appearance of the building, the second floor retains much of its integrity from the 1920s.

This building is significant because it calls direct attention to the Face Lifts on Main movement, which swept Ames in the 'Teens, 1920s, and 1930s. The building could be contributing to an historic commercial district, particularly if the problem of the second floor windows can be addressed.

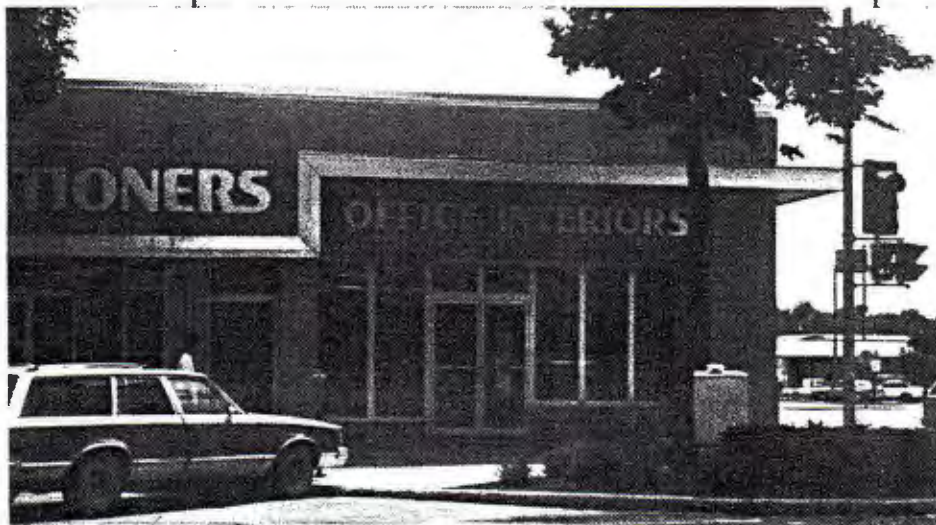
18. Map \_\_\_\_\_
19. Photo looking S Photographer Wirth

The present condition of the building precludes any claim to historical significance.

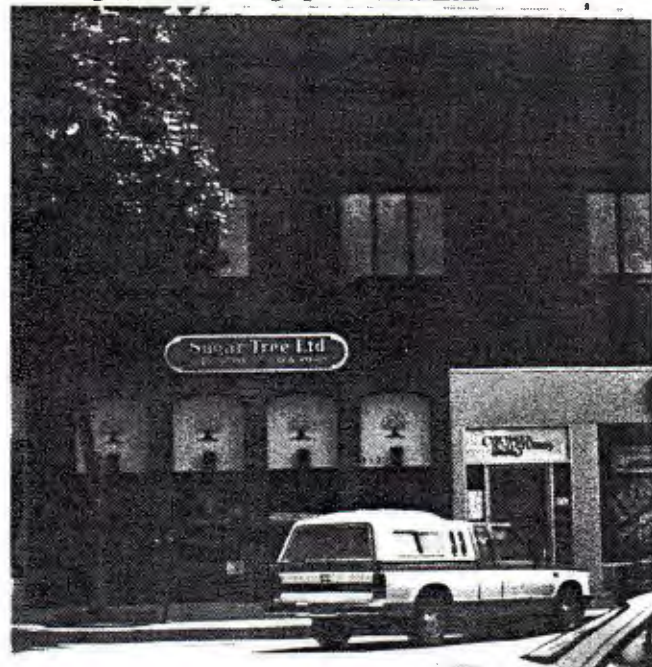
## 19. Photo looking S Photographer Wirth

Bobby Rogers Clothing Store was housed in this building. The present first floor was remodeled for this business in the 1970s, although already in the 1950s, Bobby Rogers had also remodeled the building for this same business. She also owned a woman's fashion store in Campustown, North Grand Mall, and in Marshalltown.

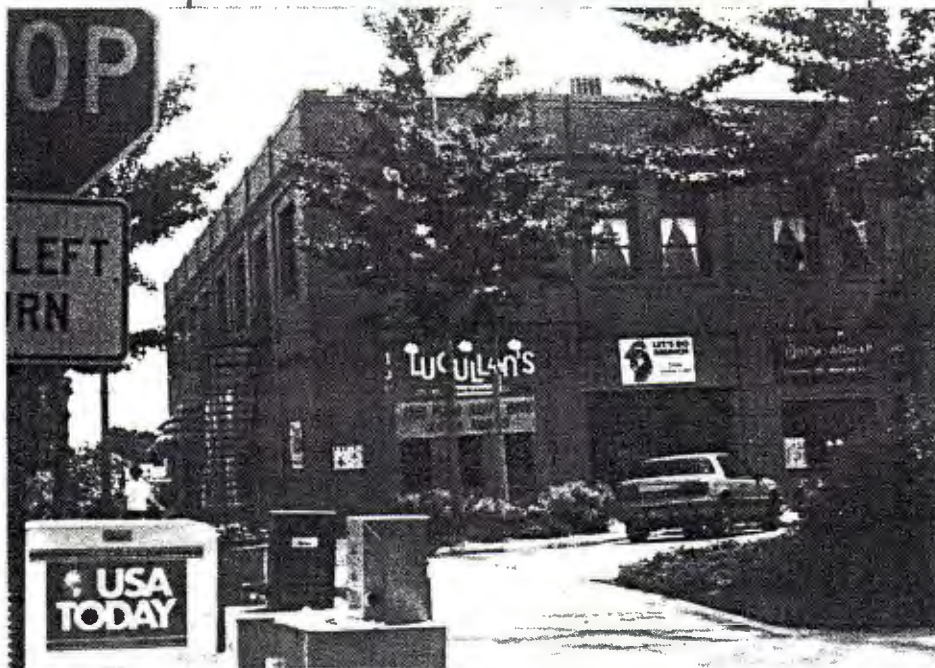
19. Photo looking S Photographer Wirth

The integrity of this building remains high. Although the three bays on the storefront have been altered, they respect the original cavities. Windows on the second floor on the east elevation are 1/1 double hung sash and appear to be original to the building.
