**COUNCIL ACTION FORM**

**SUBJECT: EXISTING BUILDINGS ON THE SANDS-MCDORMAN PROPERTY**

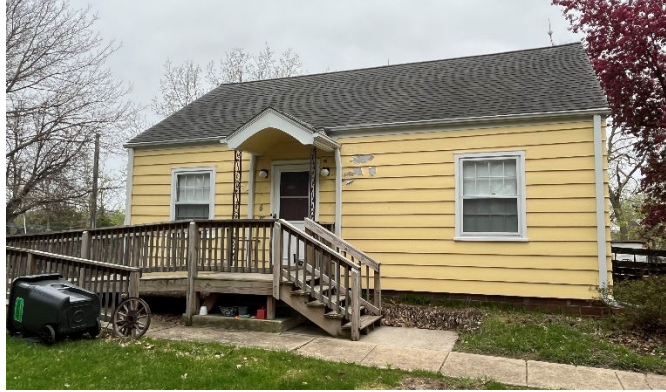
### **#1 House:**

Overall, the house is in good shape for the age of the structure. To change the use of this building from residential to commercial or business use would require some modifications such as accessible entrances, bathrooms, parking and perhaps even some structural reinforcement. Consultation with an architect is recommended to determine the feasibility of reusing this structure for anything other than residential uses.

The visual inspection indicates the garage and milk house could be used for storage after improvements are made. Further inspection of the house by an architect would need to be performed to determine what needs to be done to make the house compliant for commercial use.

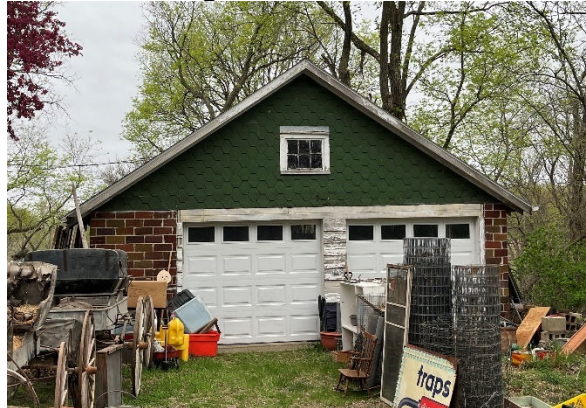
### **#2 Garage:**

This building seems structurally sound from visual inspection. The foundation and roof system are in average shape for the age of the building. The roof should be replaced, and some tuckpointing/brick work would need to be done to make the structure weather tight. With those improvements, the building could then be used for storage.

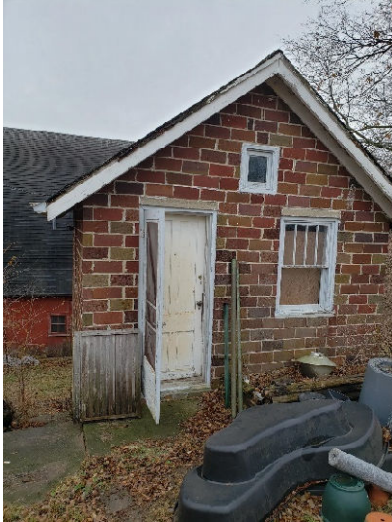
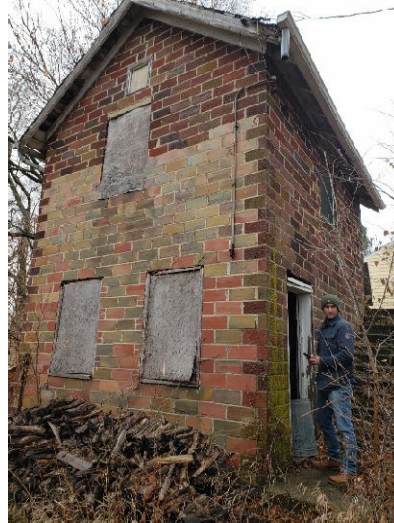
### #3 Milk House:

This structure is in good shape for the age of the building. It does need some ceiling joist repair/replacement on the top floor, a new roof, tuckpointing/brick work, and new windows to seal the building against the elements. This building could be used as storage, similar to the garage.

Functionality of the buildings is another consideration to evaluate. For example, the milk house only has a walk-in door on both levels which severely limits what can be stored in it. Even if the house was made compliant, staff does not view this as a functional building for City use and the repairs may be cost prohibitive.

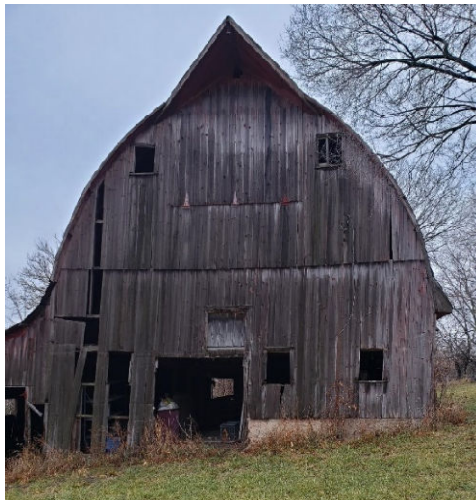
### #4 Large Barn:

This building is structurally unsafe due to several factors. It is substantially leaning to the west and the interior load bearing elements are not properly supported. The foundation of this structure is in bad condition as well. It is recommended that this building not be used for storage or occupancy in its current condition. However, there is some value in the old lumber.

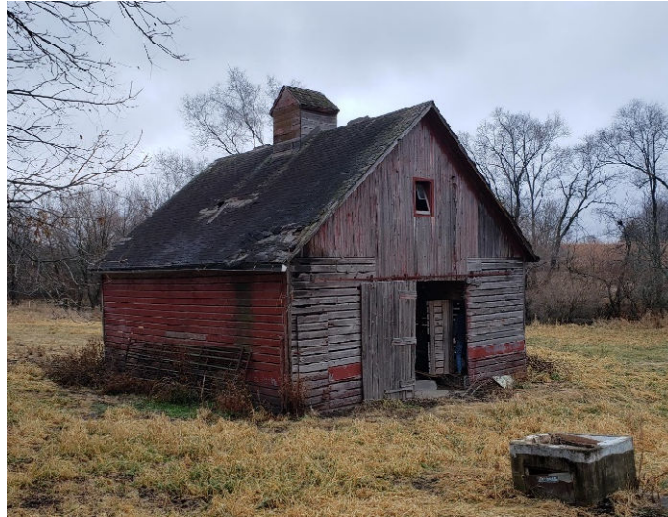
### **#5 Small Barn / Corn Crib:**

The foundation of the building is below average with some noticeable cracking under the load bearing walls. The roof structure seems inadequate due to rotting wood members. This building should not be used in its current condition but has value in the lumber, same as the Large Barn.
