loway Creek

Brookside Park, Ames, IA

Existing Conditions Assessment & Restoration Concept

NREM 455L/555L, fall 2021
Iowa State University

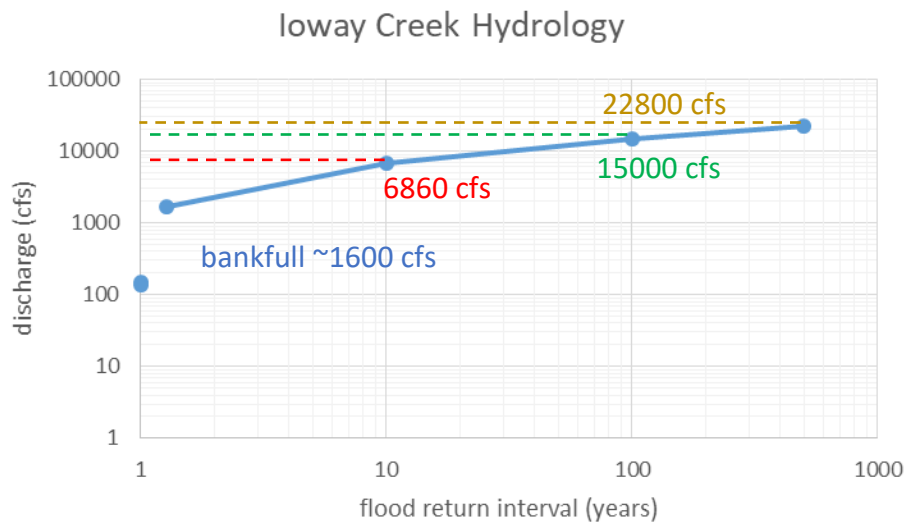
Figure 6. Peak flow data for design-relevant events at station 05470500, Ioway Creek at Lincoln Way.

The data used to make the graph above (Figure 6) is from the USGS Streamstats compilation of NWIS data. The points correspond to discharge at the annual mean, existing-conditions bankfull, 10-year, and extrapolated 100- and 500-year floods. Most of Brookside Park falls within the FEMA floodplain for the 100-year (1% AEP) flood event.

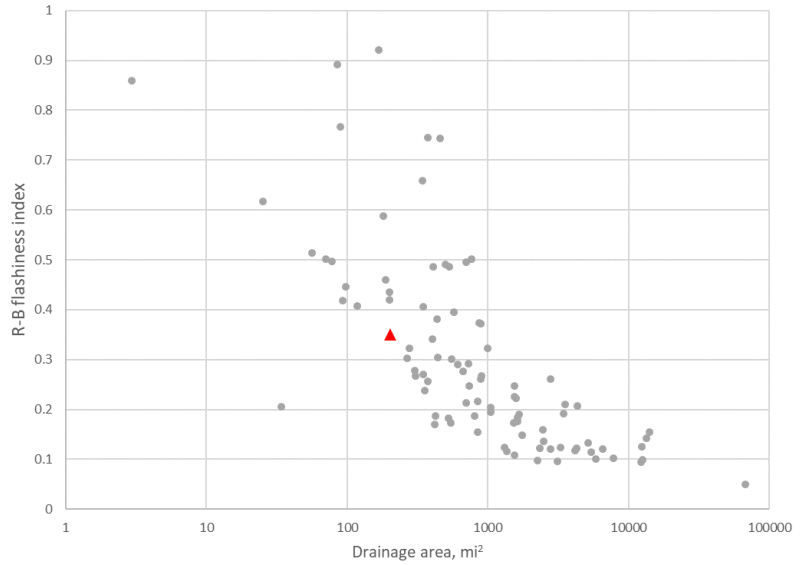
Figure 7. R-B flashiness index plotted as a function of drainage basin area (log-scale) for USGS gages in Iowa. loway Creek is shown as a red triangle.

To address these questions in the context of a partially-urbanized loway Creek catchment, we explored the possibility that loway Creek is unusually flashy. To evaluate this, we used the Richards-Baker (or R-B) flashiness index, computed for all gage stations in Iowa with at least 20 years of record (Figure 7). loway Creek (red triangle) appears to be no more flashy than other Iowa streams in its size range, and is perhaps less so. However, there does appear to be some non-stationarity to the discharge records. Figure 8 shows the median of each year’s daily mean discharges from 1965 to 2018, along with a best-fit trendline. While we don’t expect any strong correlations to be present in a time series like this, there is an indication at all quantiles of the discharge record of a positive trend. In other words, Figure 8 indicates that the median discharge is increasing by an average of more than 0.5 cfs per year, or nearly 1% per year. This suggests that a conservative and climate-adaptive design approach should incorporate some expectation of increased flows in the coming decades.

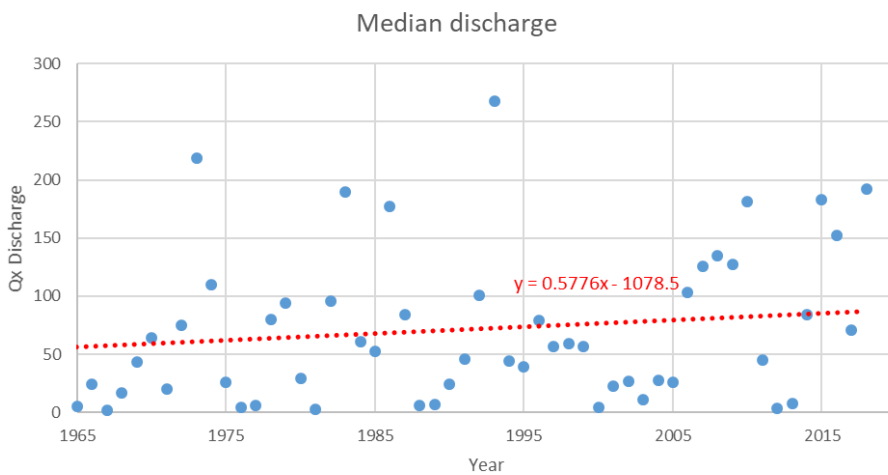
Figure 8. Median daily discharge for each year since 1965 at the USGS loway Creek gage.

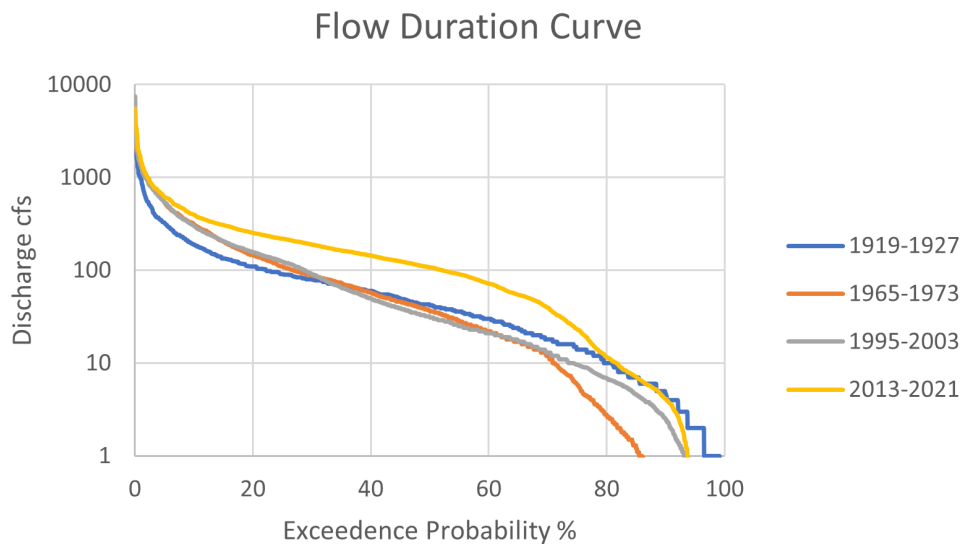
Figure 9. Flow duration curve for four 8-year intervals between 1919 and 2021. Plotted using daily mean discharge data from the USGS gage station 05470500 on loway Creek at Lincoln Way, Ames.

The flow duration curves show that there has been a shift in flow magnitude and frequency throughout the studied time periods, consistent with the analyses above. The 1919 -1927 interval shows that a flow of 100 cfs was exceeded only approximately 20% of the time during those eight years. Whereas the flow of 100 cfs during the 2013- 2021 interval was exceeded approximately 55% of the time. This means that loway Creek at Lincoln Way is transporting higher flows more frequently during the past 8 years than it did in any of the other intervals. This could be attributed to urbanization upstream and additional storm water outlets installed without retention basins, or could reflect an extrinsic change in streamflow that has been widely observed in the U.S. starting in the 1970s (McCabe and Wolock, 2002). This analysis is important because there may be design implications associated with the increased flows. This data suggests the channel of loway Creek at Brookside Park may need to accommodate larger flows than the drainage area might indicate.

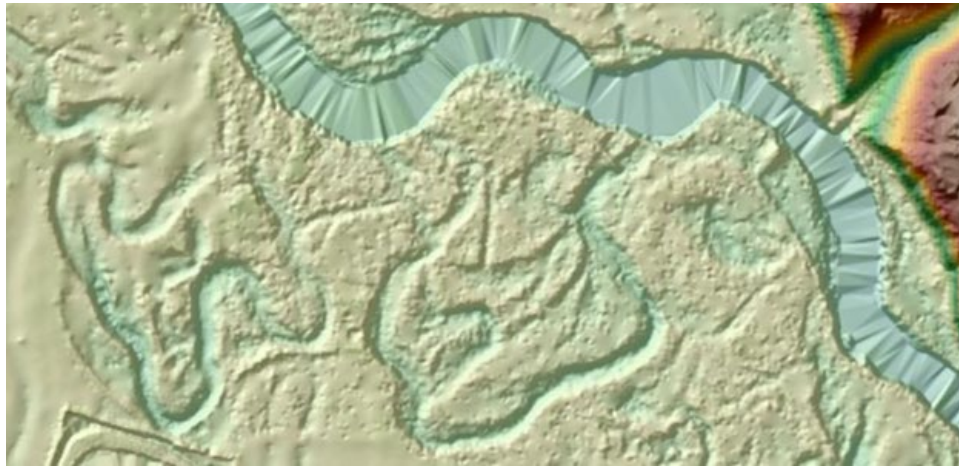
Figure 12. LiDAR color hillshade from the Iowa Geographic Map Server of the northern reach of loway Creek and the wooded floodplain in Brookside Park.

At first glance, it's easy to see the 1900 reference channel was much narrower and more sinuous than it is presently, assuming that it occupied a single-thread channel. A more in-depth analysis revealed, using the same bankfull discharge calculation method as before but with dimension and pattern parameters extracted from the channel scars, that the bankfull depth of the historic stream was about 3.3 feet (Figure 13) with a corresponding discharge of approximately 1000 cfs. That discharge would be exceeded on more than 7 days per year according to the current flow duration curve, and would very likely yield an unstable channel if implemented under today's flow regime.

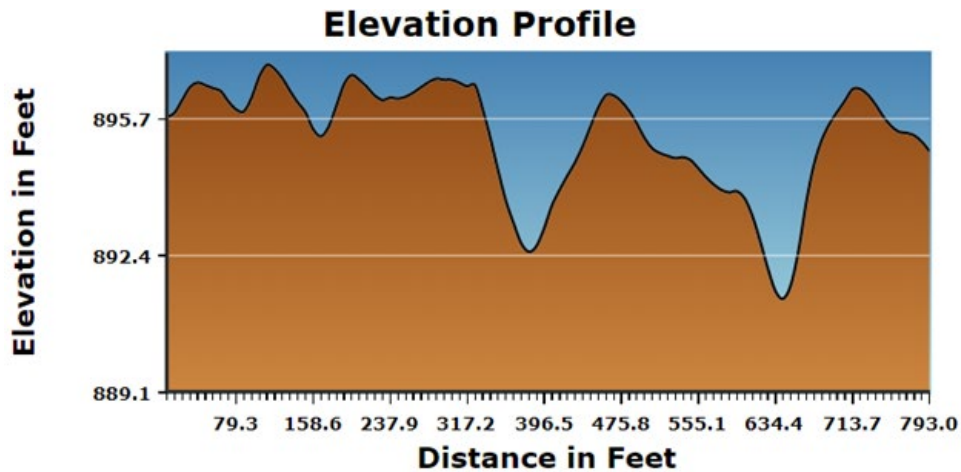
Figure 13: Elevation profile generated using the Iowa DNR elevation profile tool. This cross-section illustrates the pre-1900 channel dimensions of loway Creek.

From the elevation cross-section of the old channels, it is easy to see the cross-sectional area is much smaller than present-day loway Creek. This form of loway Creek represents a different time in terms of hydrologic setting, and replication of this channel form and dimensions would be inadvisable.

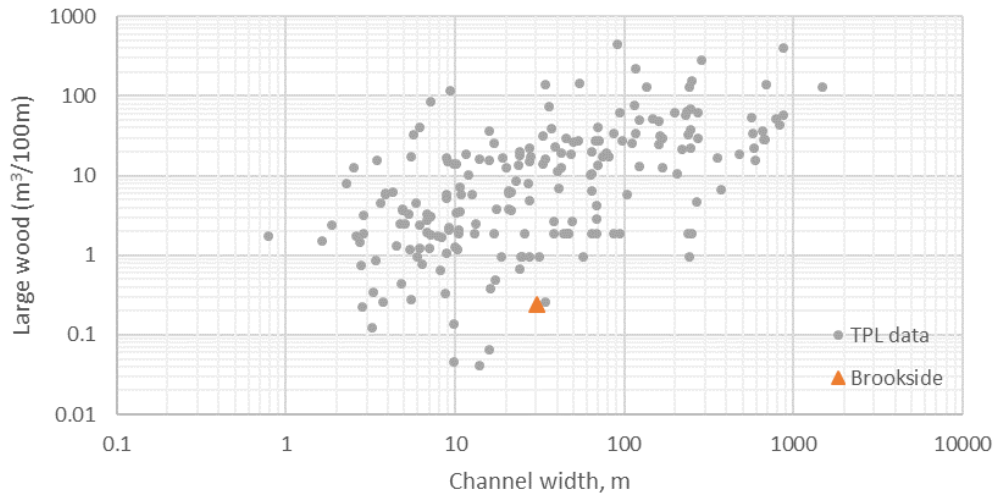
Habitat assessments that we were able to complete despite the poor flow conditions included a large wood inventory, riffle pebble counts, and facet (also known as geomorphic channel units) mapping. We used a simplified large wood tally method with 9 different diameter-length categories to estimate wood volumes within the baseflow (zone I) and bankfull (zone II) channel. We also used data from the EPA's National Rivers and Streams Assessment (NRSA) to provide some context for our results. Expressed in terms of wood volume per 100 meters of stream length, we found approximately 0.24 m³/100m in our study reach. While this number alone may not be particularly revealing, a comparison with other rivers and streams in the same (temperate plains) ecoregion suggests that this reach has a relatively small wood load (Figure 15).

Figure 15. A log-log plot showing large wood volume per channel length as a function of channel width. Brookside large wood data from this study are very low compared with other sites in the region.

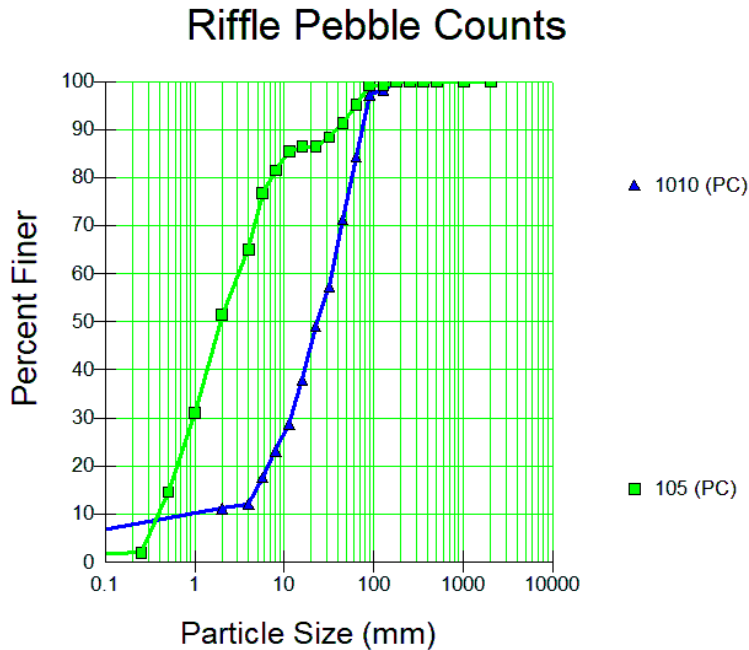
Bed particle size was measured using the Wolman pebble count method in areas identified as riffles or runs Figure 16. The upstream site was located near station 1+05, which was not a proper riffle but rather a scoured section of bed at the downstream end of the channel constriction below the north footbridge. Particle sizes there included sand and gravel, as well as a small number of cobbles. D₅₀ (the median particle size) was roughly 2mm. A second riffle, located downstream at station 10+10, appeared to be a partially constructed riffle, as it was composed of both natural till-derived cobbles and broken concrete arranged across the channel near the downstream end of the till bluff. The D₅₀ in

this riffle was considerably higher, approximately 24 mm, but these coarser particle sizes were found in relatively few places elsewhere on the bed. Considering these findings, we used the finer D_{50} in analyses related to channel classification and bedload transport. The coarser bed found in the 10+10 riffle is important, however, as it provides a greater degree of vertical channel stability in the only functional riffle within the reach.

Figure 16. Riffle particle-size distributions from stations 10+10 (green squares) and 1+05 (blue triangles).
